OUTFALL SUMMARY REPORT

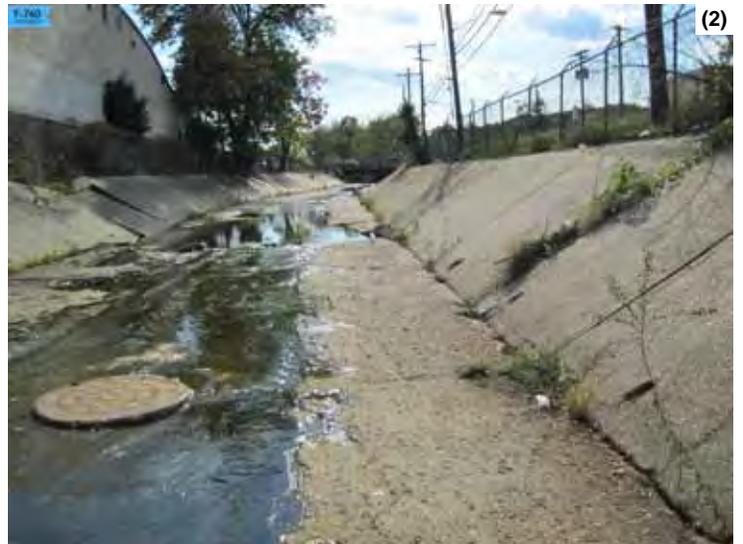
(1)

Minor cracking of concrete channel wall above and around pipe.

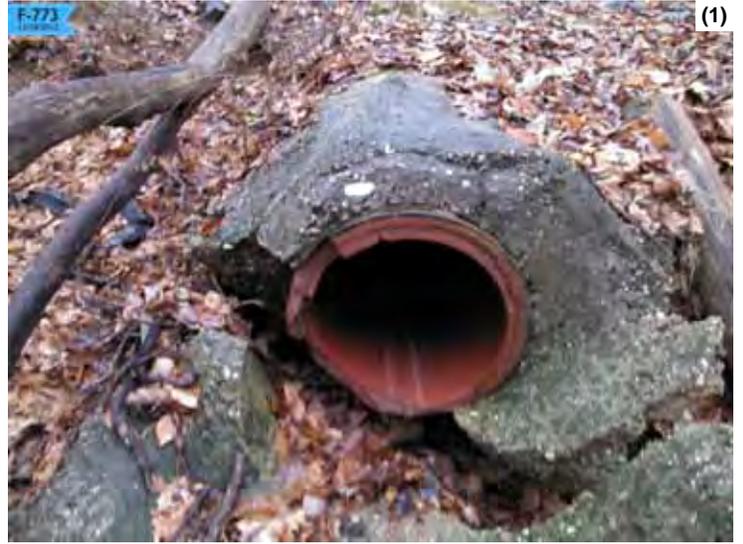
Pipe broken on end, but has been this way since at least 1884 (dog tag present).

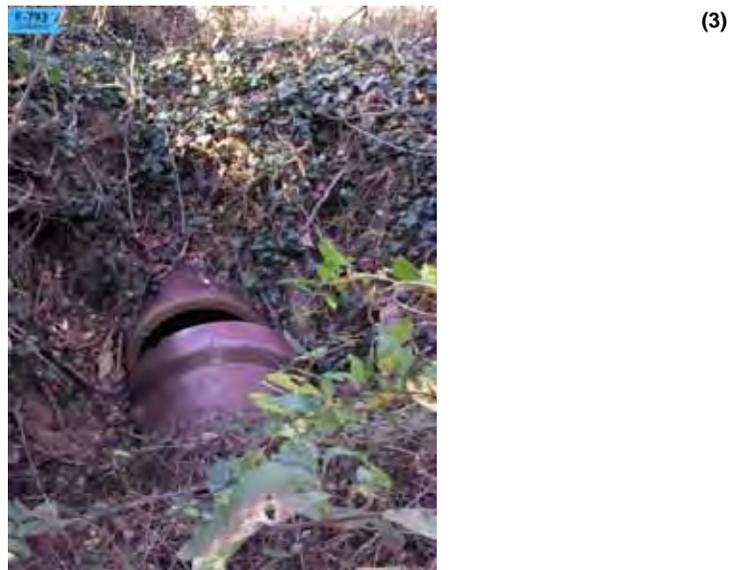
Erosion around pipe has caused large ravine. Total depth of ravine is approx 10 ft

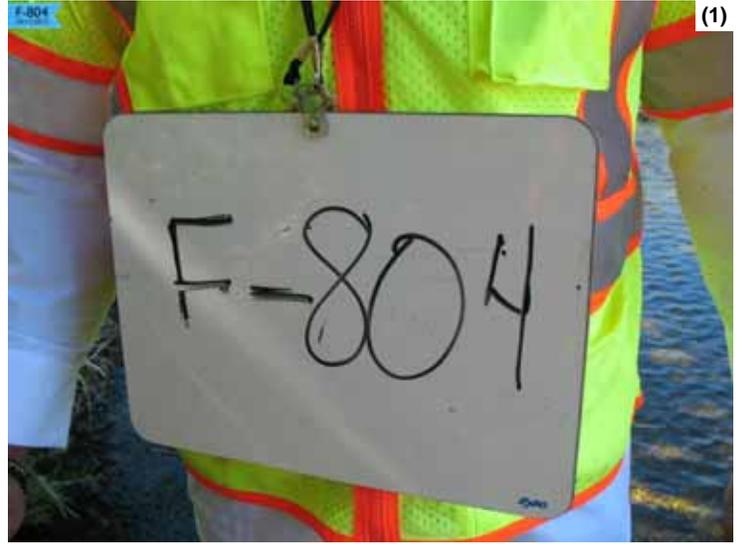
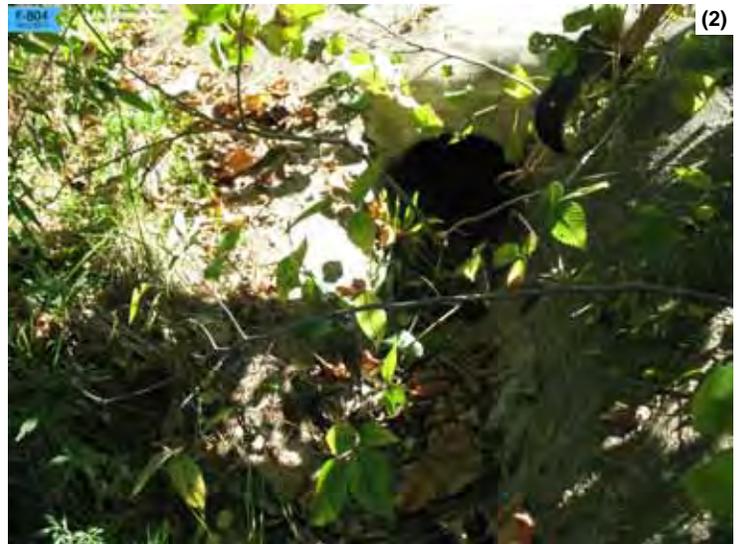
Minor cracking in concrete headwall with roots growing in cracks.
