OUTFALL SUMMARY REPORT

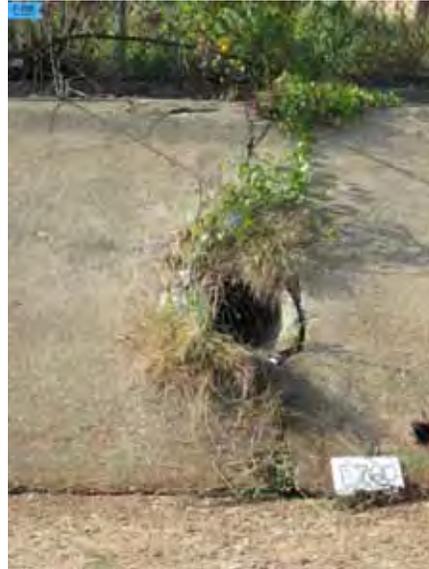
(1)

Minor cracking of concrete channel wall above and around pipe.

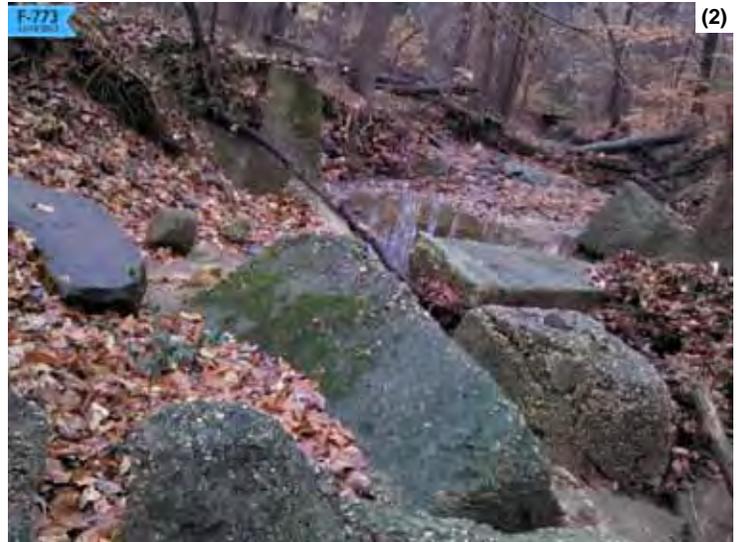
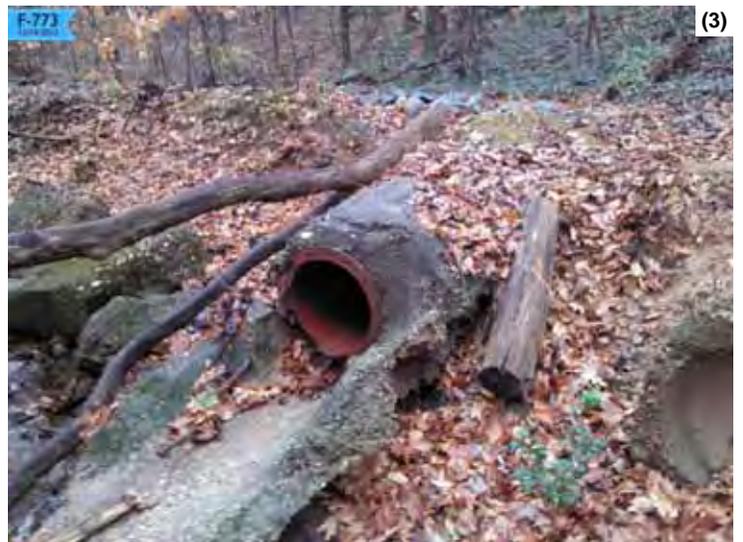
Pipe broken on end, but has been this way since at least 1884 (dog tag present).

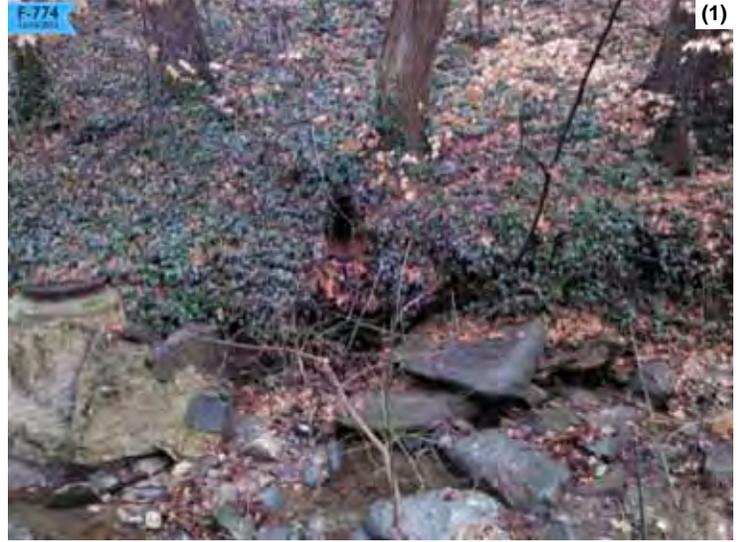
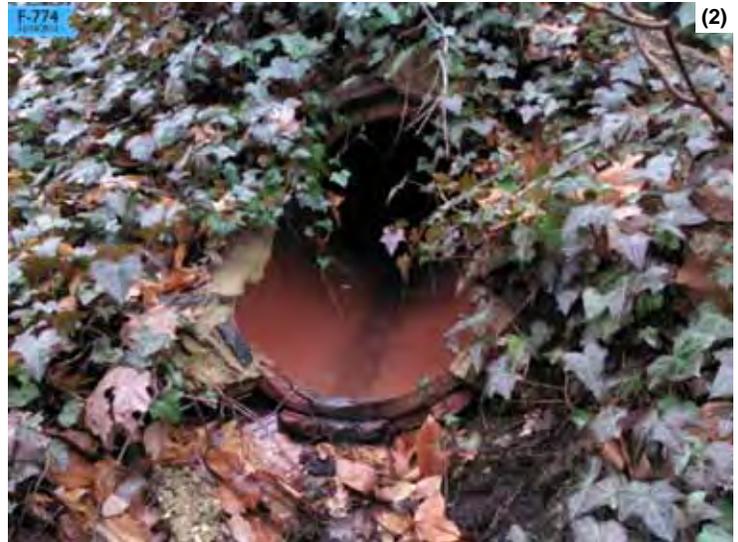
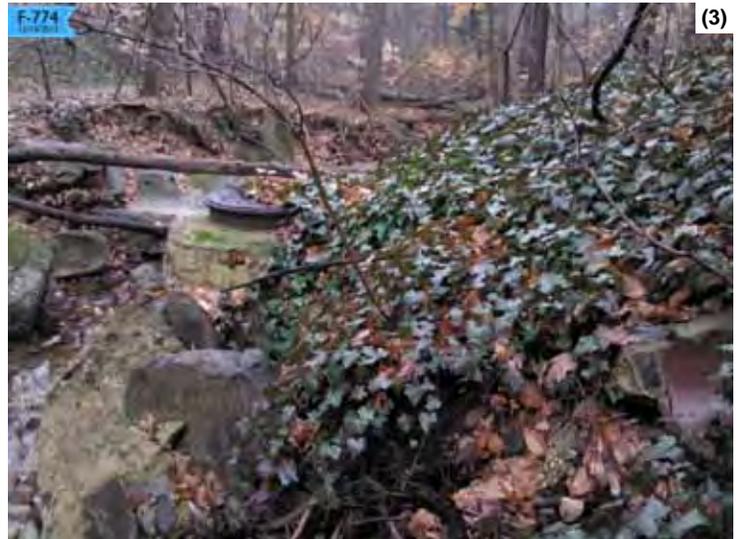
broken piece downstream

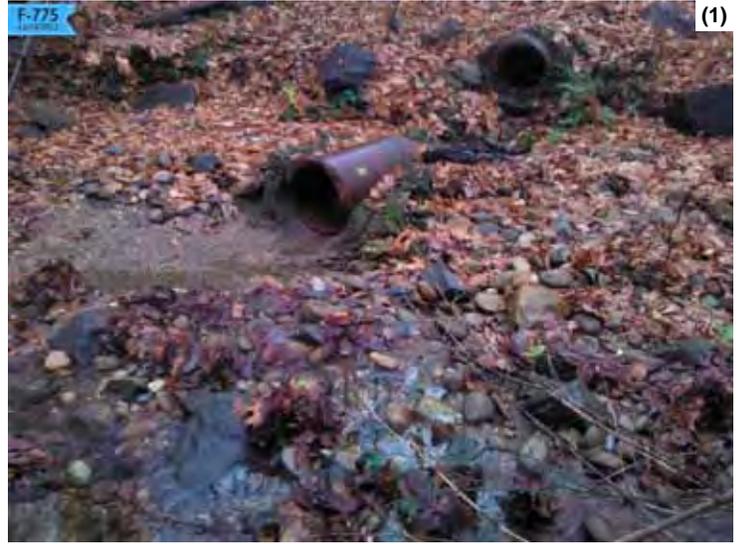
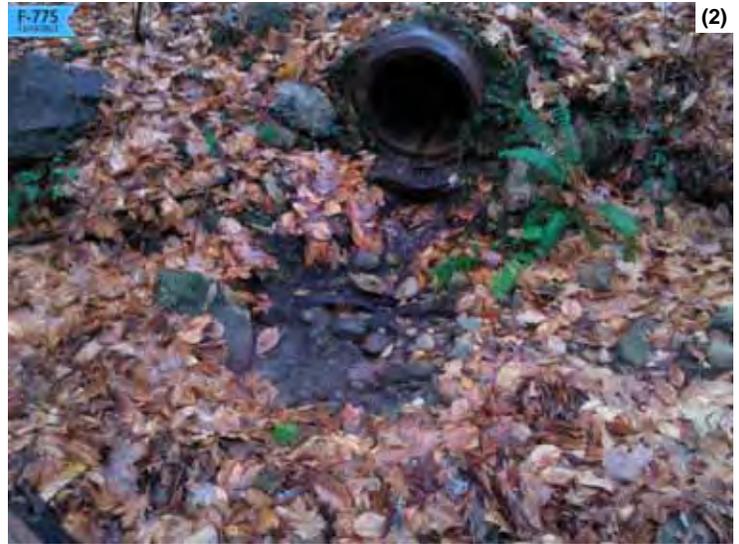
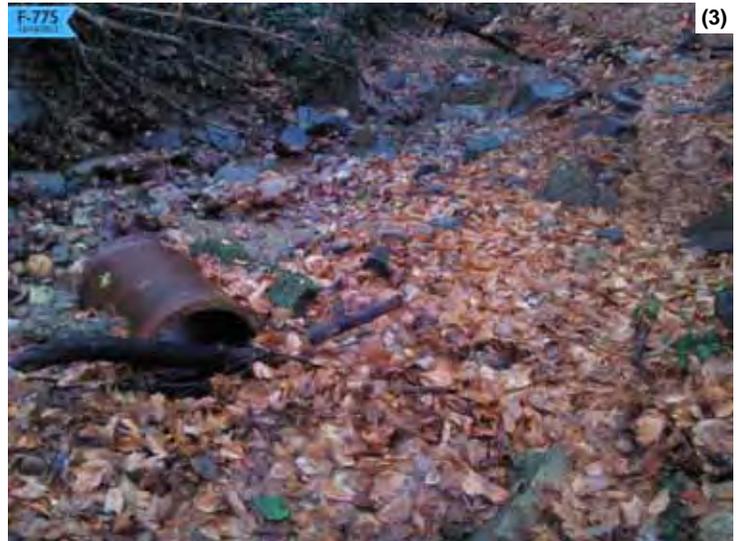
Broken pipe in stream.

Remove broken pipe from stream.

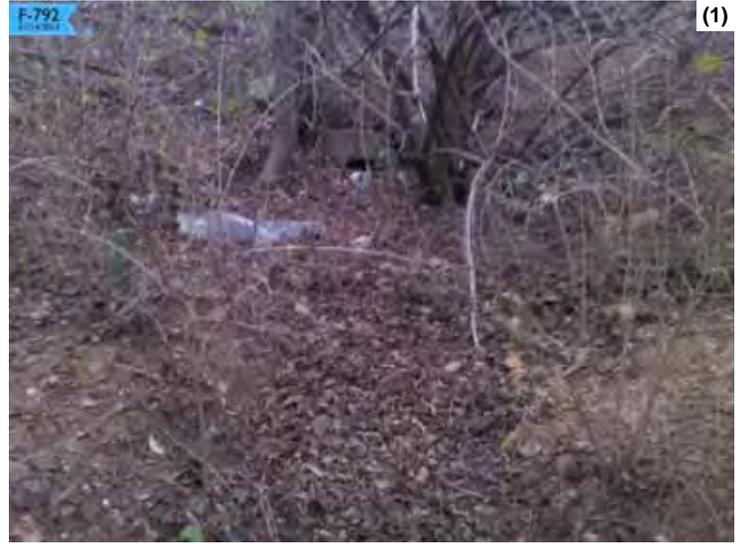
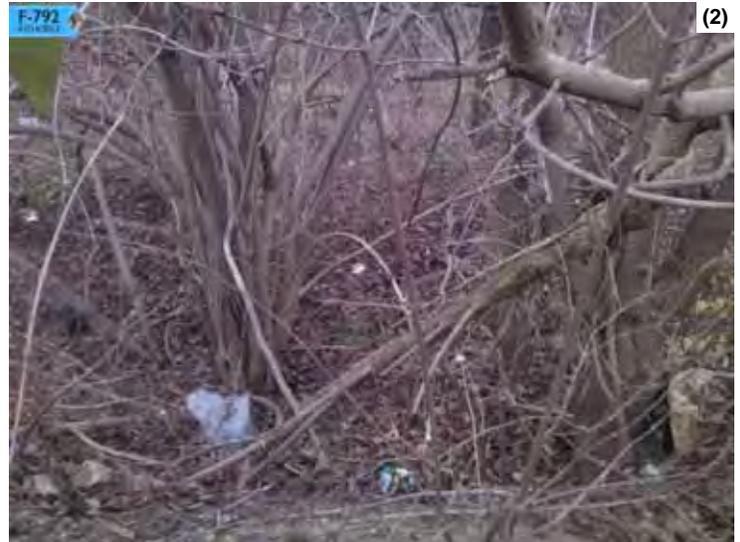
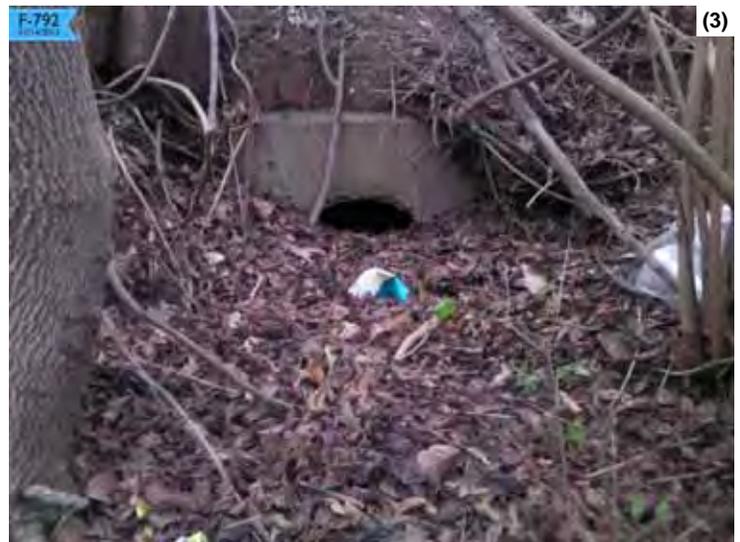
Stream Bank / Pool	<input type="text" value="1"/>	<input type="text" value="Some Erosion"/>	Repairs Recommended? NO
Stream Bank / Pool (x2)	<input type="text" value="2"/>		
Structure	<input type="text" value="0"/>	<input type="text" value="Excellent / Like New"/>	
Criticality	<input type="text" value="0"/>	<input type="text" value="Normal"/>	
Total Score	<input type="text" value="2"/>	<i>Total = Stream Bank / Pool x2 + Structure + Criticality</i>

Channel possibly caused by erosion down to drainage ditch.

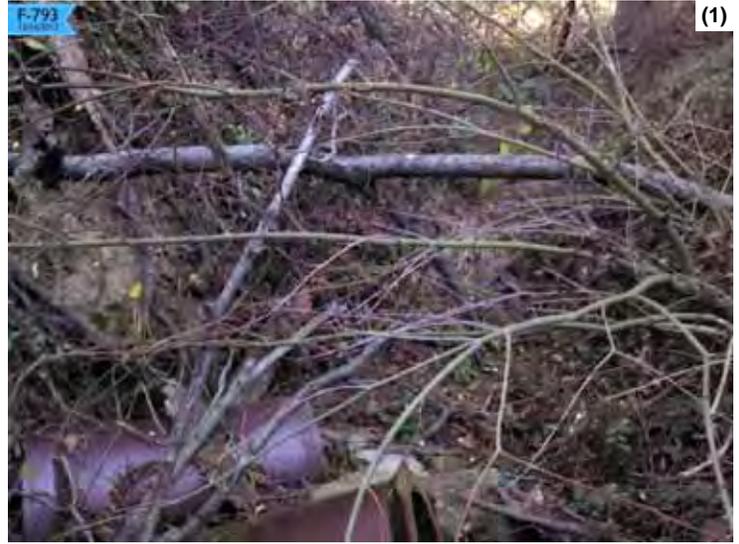
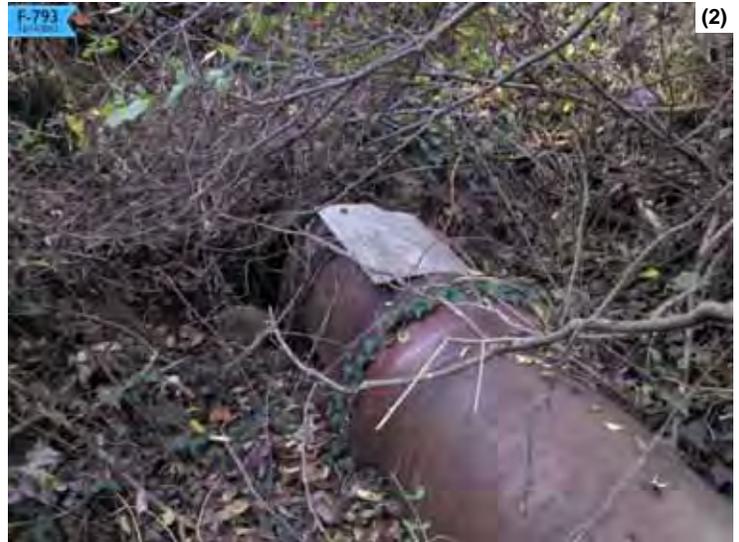
Stream Bank / Pool	<input type="text" value="2"/>	<input type="text" value="Active Erosion"/>	Repairs Recommended? <input checked="" type="text" value="YES"/>
Stream Bank / Pool (x2)	<input type="text" value="4"/>		
Structure	<input type="text" value="2"/>	<input type="text" value="Poor"/>	
Criticality	<input type="text" value="0"/>	<input type="text" value="Normal"/>	
Total Score	<input type="text" value="6"/>	<small>Total = Stream Bank / Pool x2 + Structure + Criticality</small>

Erosion around pipe has caused large ravine. Total depth of ravine is approx 10 ft

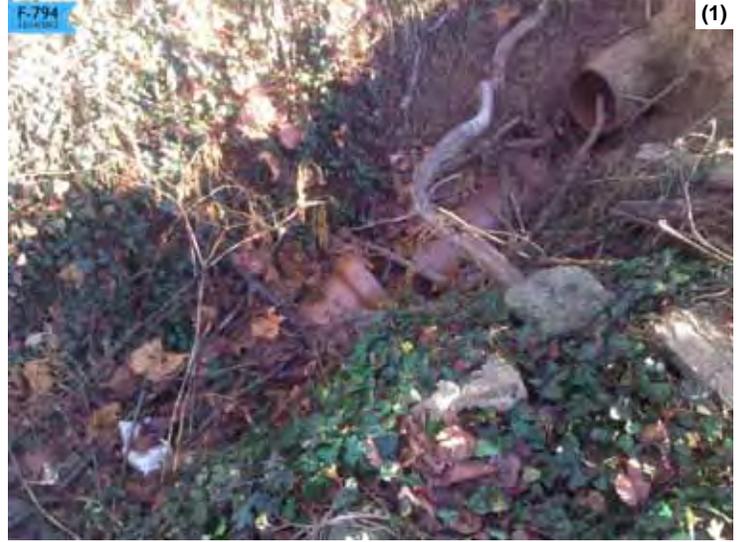
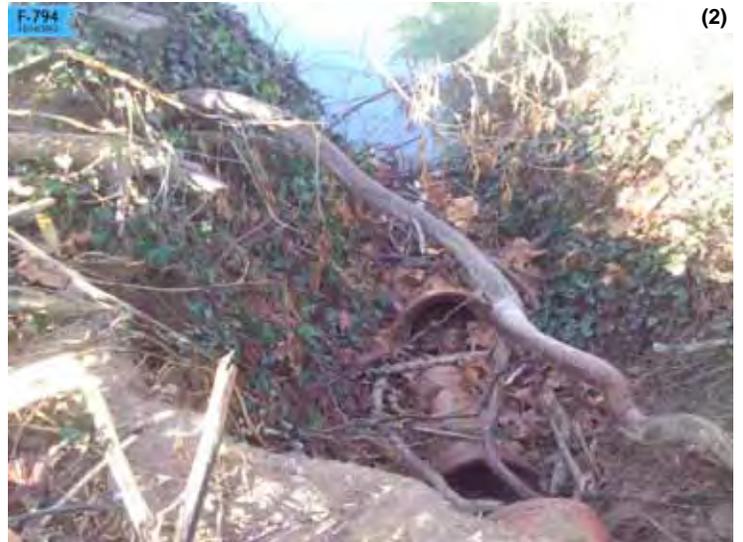
Stream Bank / Pool	<input type="text" value="1"/>	<input type="text" value="Some Erosion"/>	Repairs Recommended? <input checked="" type="checkbox"/> YES
Stream Bank / Pool (x2)	<input type="text" value="2"/>		
Structure	<input type="text" value="2"/>	<input type="text" value="Poor"/>	
Criticality	<input type="text" value="0"/>	<input type="text" value="Normal"/>	
Total Score	<input type="text" value="4"/>	<small>Total = Stream Bank / Pool x2 + Structure + Criticality</small>

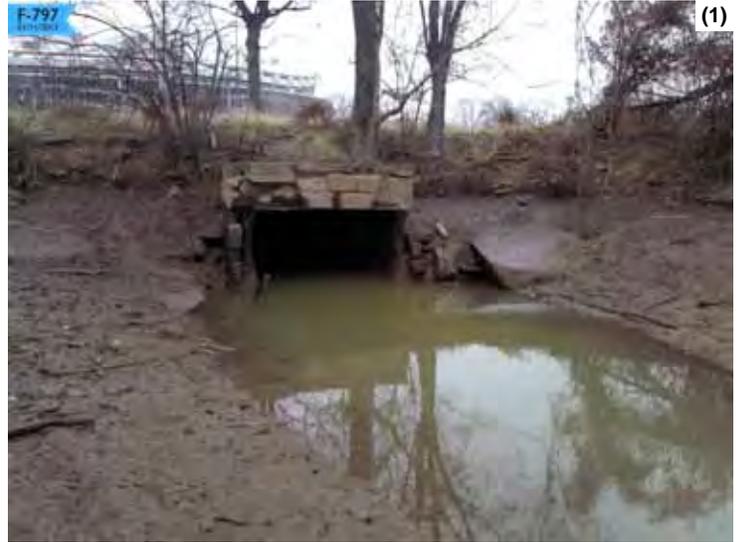
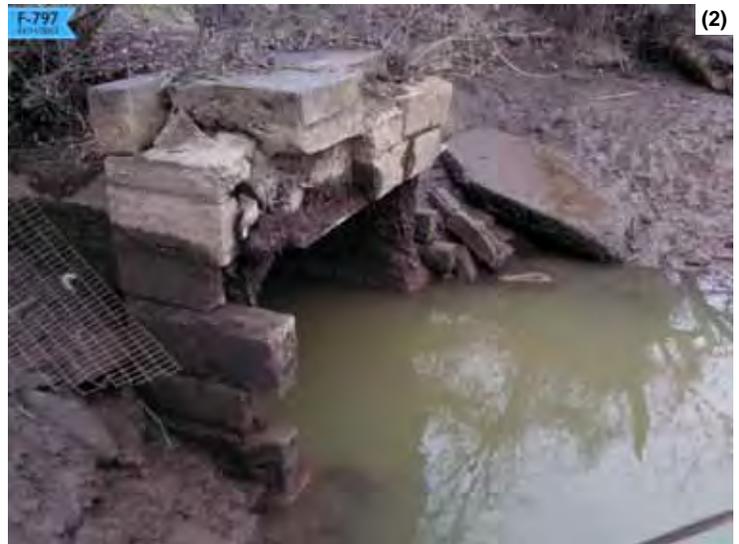
Stream Bank / Pool	<input type="text" value="1"/>	<input type="text" value="Some Erosion"/>	Repairs Recommended? YES
Stream Bank / Pool (x2)	<input type="text" value="2"/>		
Structure	<input type="text" value="2"/>	<input type="text" value="Poor"/>	
Criticality	<input type="text" value="0"/>	<input type="text" value="Normal"/>	
Total Score	<input type="text" value="4"/>	<small>Total = Stream Bank / Pool x2 + Structure + Criticality</small>

Structure interior concrete walls are deteriorated. Headwall is broken and near collapse.

Point Repair

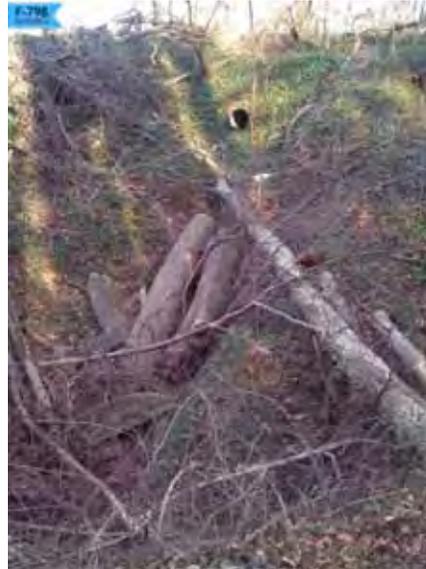
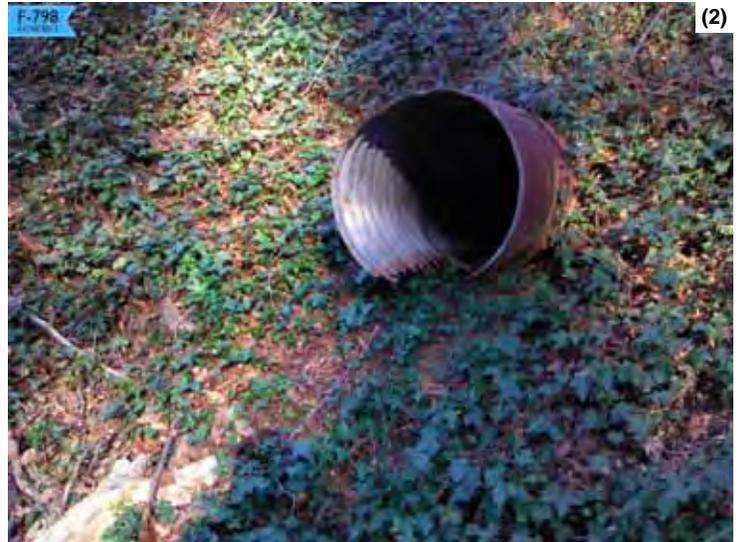
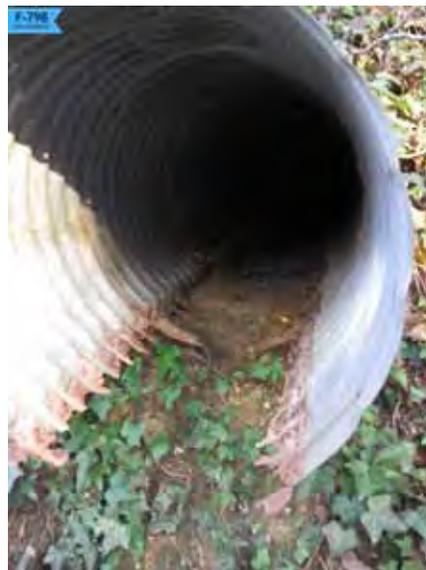
Stream Bank / Pool	<input type="text" value="2"/>	<input type="text" value="Active Erosion"/>	Repairs Recommended? YES
Stream Bank / Pool (x2)	<input type="text" value="4"/>		
Structure	<input type="text" value="2"/>	<input type="text" value="Poor"/>	
Criticality	<input type="text" value="0"/>	<input type="text" value="Normal"/>	
Total Score	<input type="text" value="6"/>	<small>Total = Stream Bank / Pool x2 + Structure + Criticality</small>

Bottom of pipe is deteriorated. Severe downstream erosion.

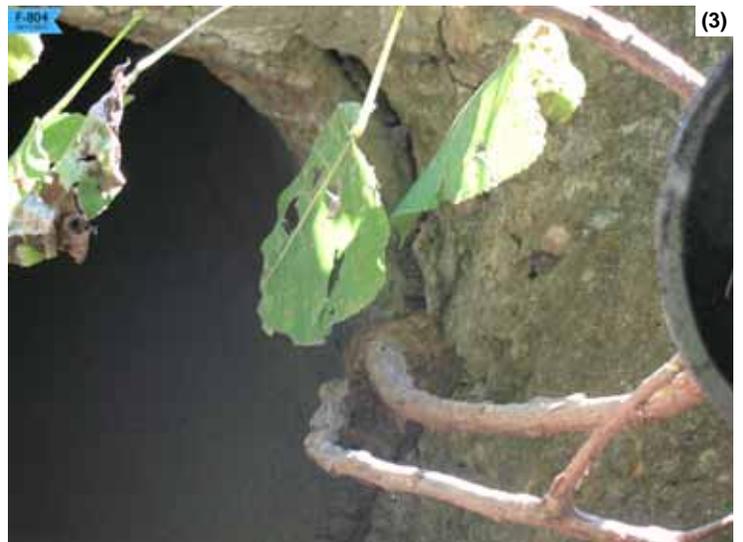
Minor cracking in concrete headwall with roots growing in cracks.

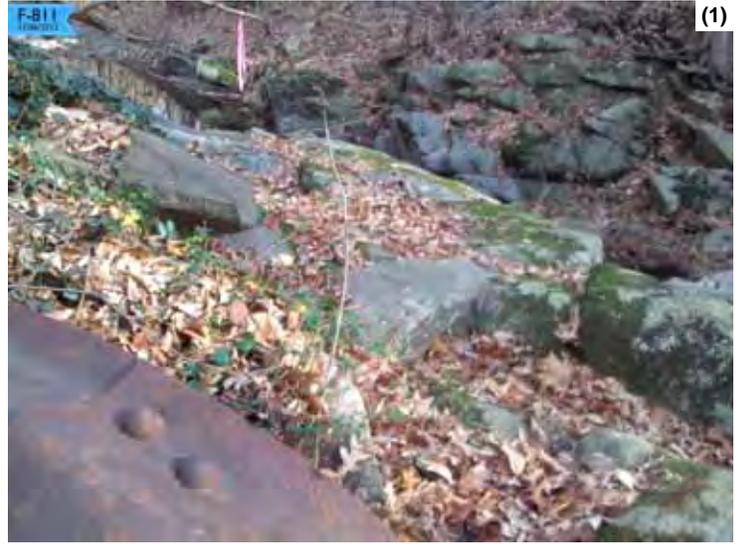
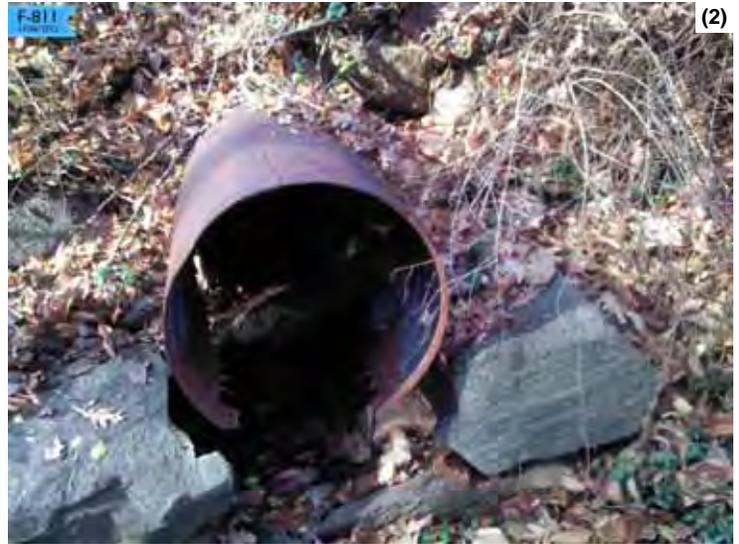
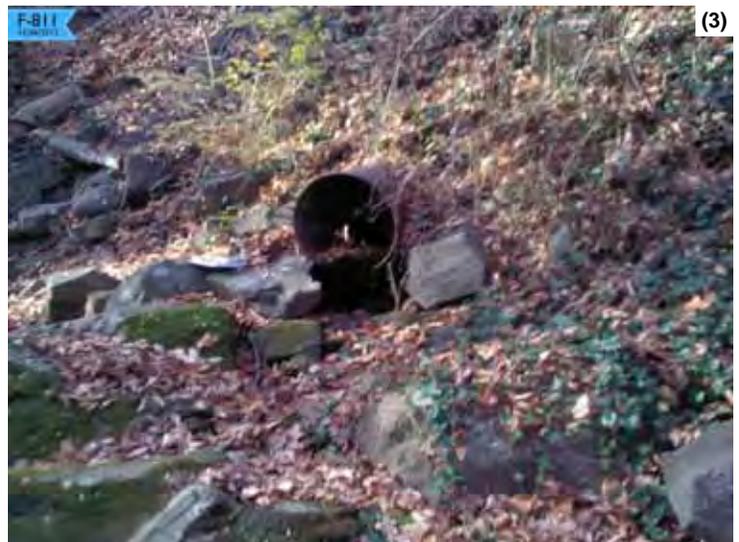
CMP is rusted out at bottom.

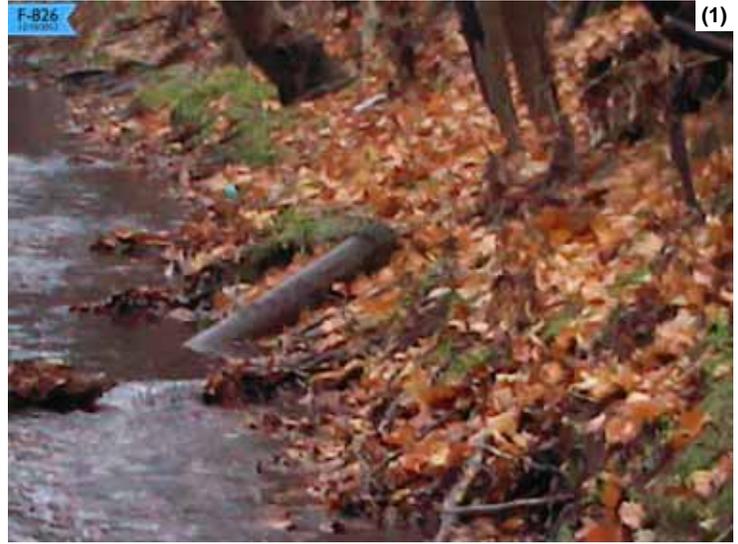
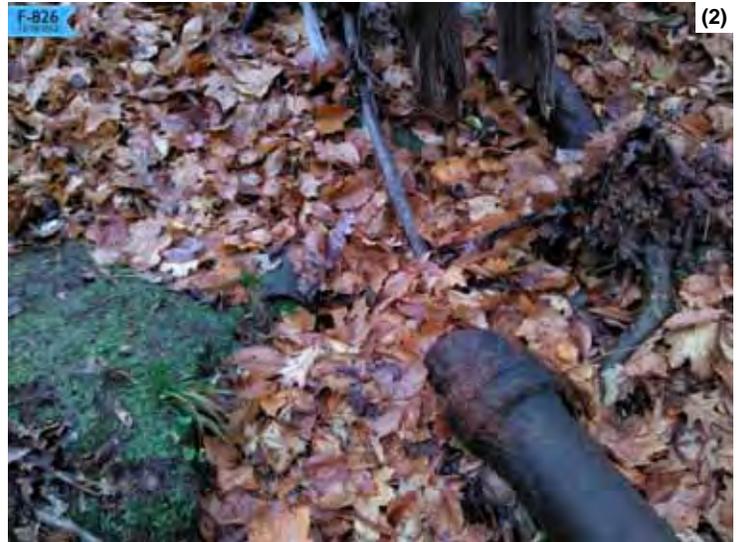
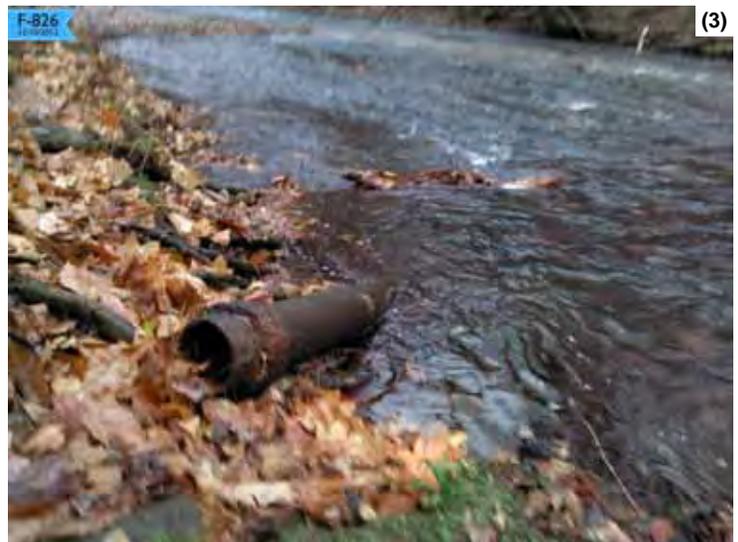
fully clogged. broken pipe slightly downstream

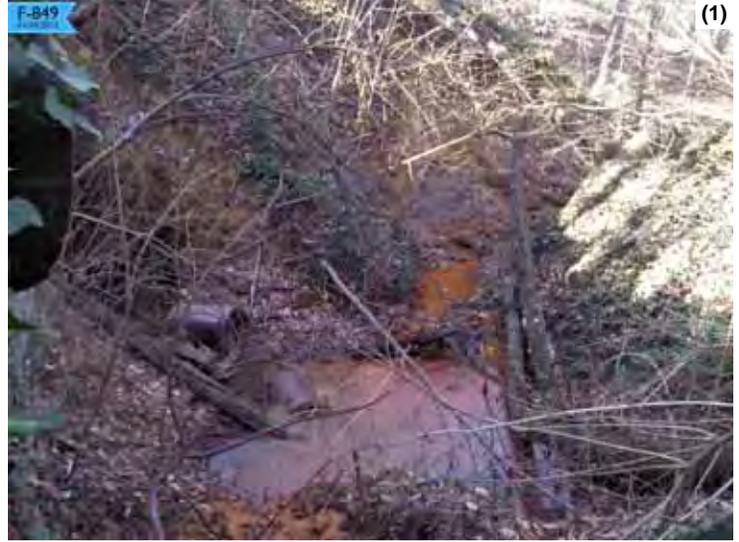
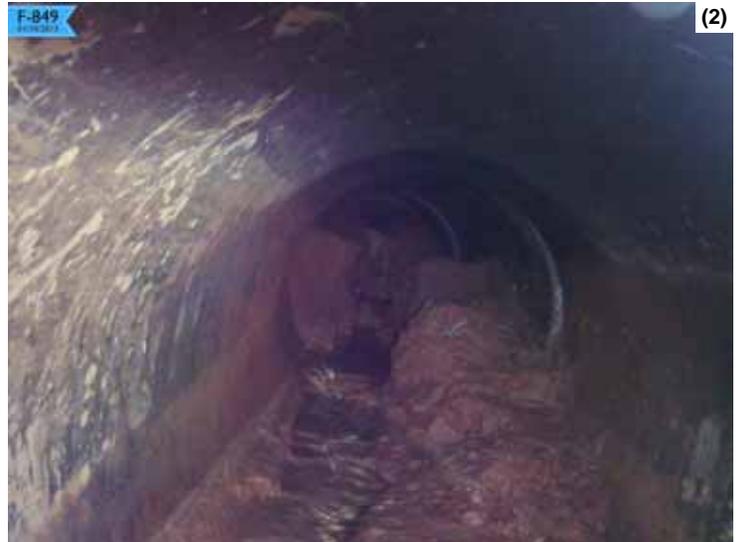
Stream Bank / Pool	<input type="text" value="3"/>	<input type="text" value="Severe Erosion"/>	Repairs Recommended? YES
Stream Bank / Pool (x2)	<input type="text" value="6"/>		
Structure	<input type="text" value="3"/>	<input type="text" value="Very Poor"/>	
Criticality	<input type="text" value="0"/>	<input type="text" value="Normal"/>	
Total Score	<input type="text" value="9"/>	<small>Total = Stream Bank / Pool x2 + Structure + Criticality</small>

Ravine erosion 5ft drop at outfall. Severe erosion caused a large ravine downstream. Pipe is clogged. Pipe joints are open and misaligned.

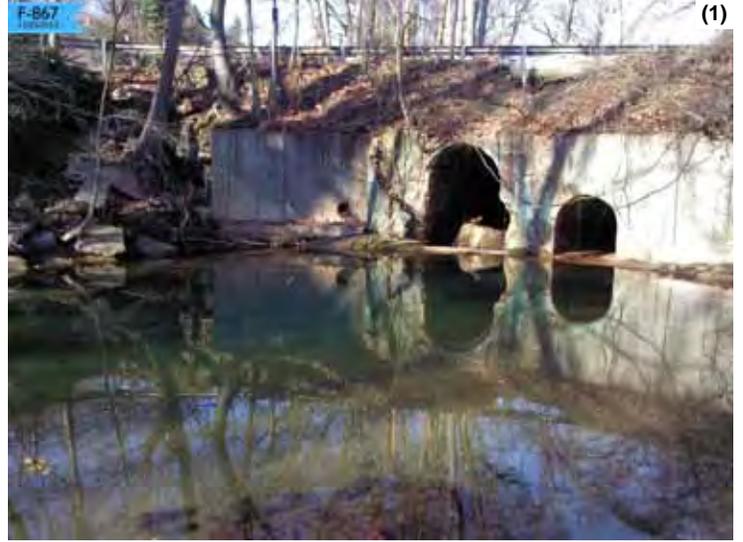
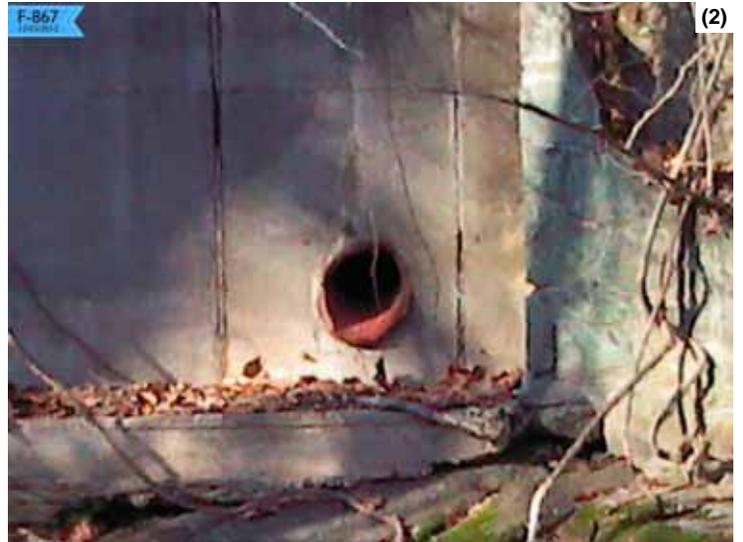
DDOT is going to repair entire area due to collapsed culvert. Could not get close enough for detailed inspection.

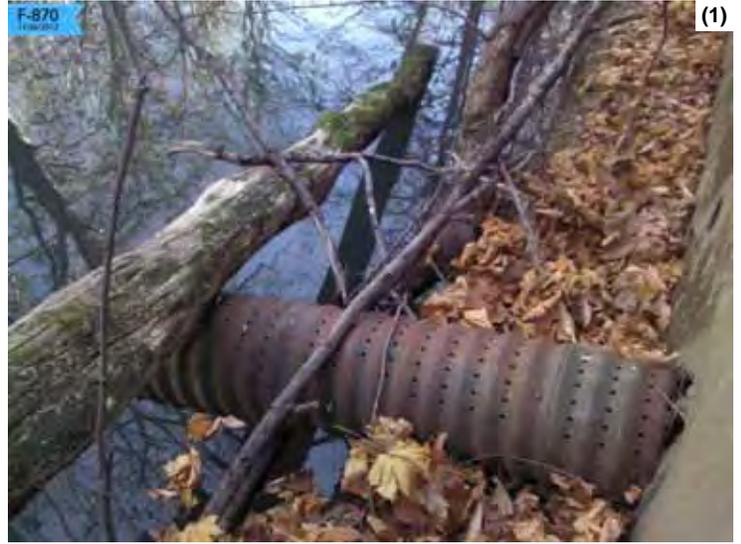
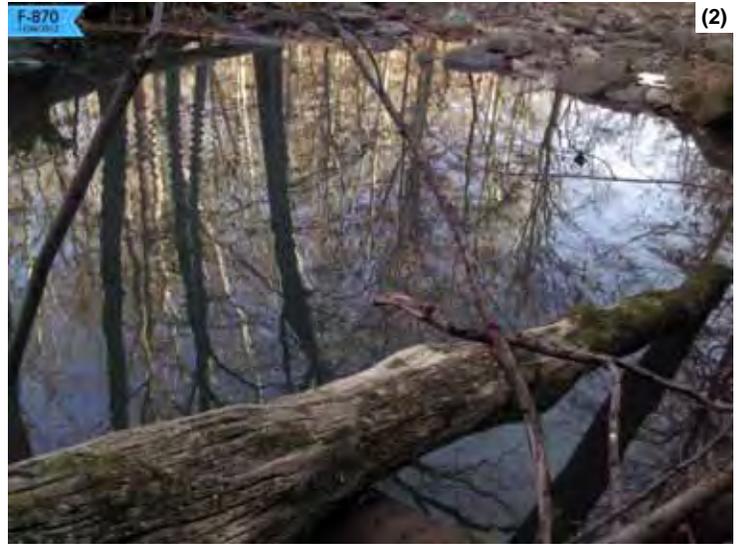
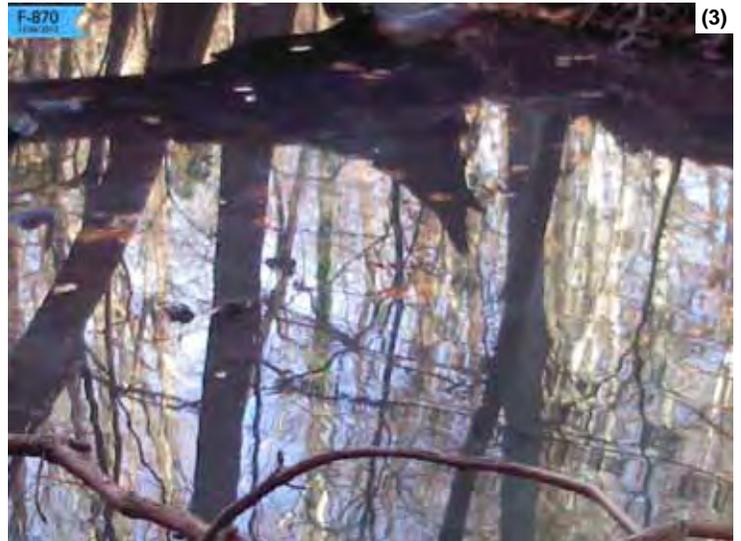
CMP is rusted out.

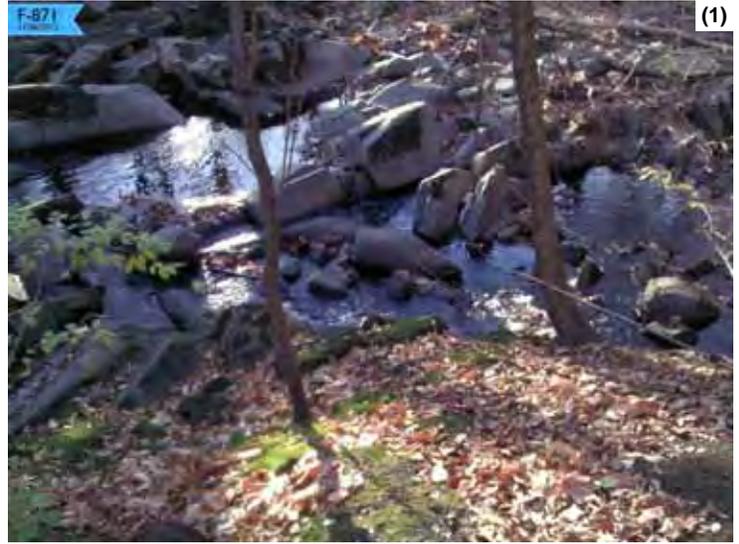
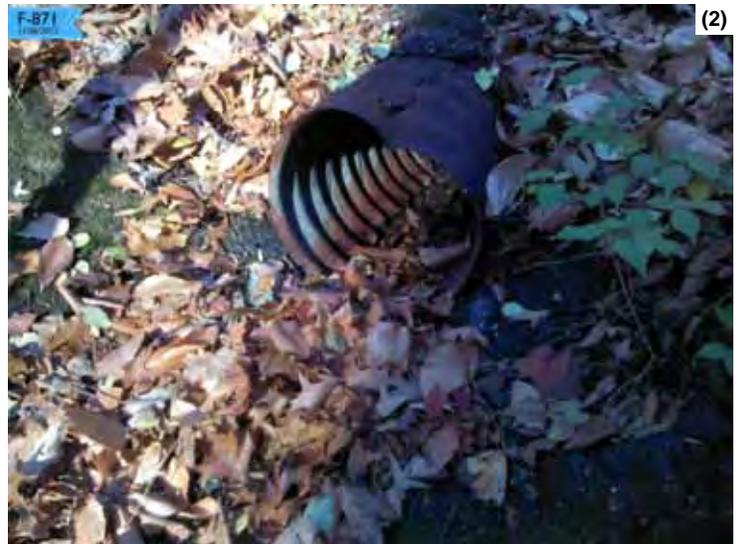
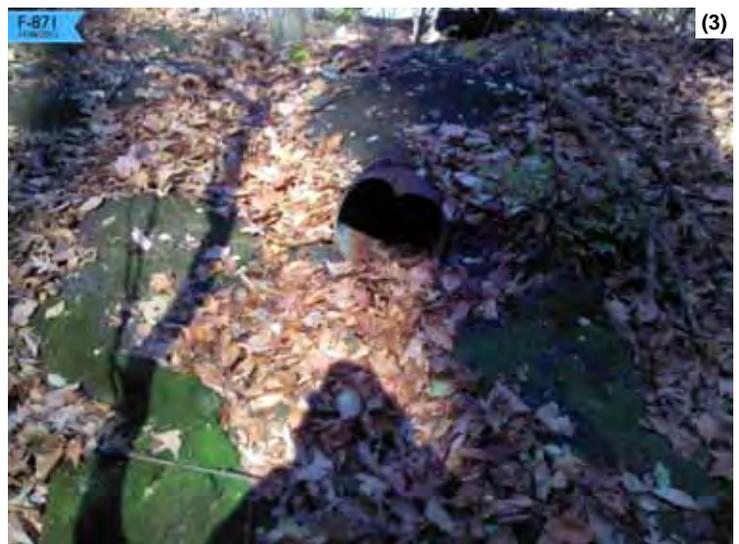
Stream Bank / Pool	<input type="text" value="0"/>	<input type="text" value="Stable"/>	Repairs Recommended? NO
Stream Bank / Pool (x2)	<input type="text" value="0"/>		
Structure	<input type="text" value="2"/>	<input type="text" value="Poor"/>	
Criticality	<input type="text" value="0"/>	<input type="text" value="Normal"/>	
Total Score	<input type="text" value="2"/>	<small>Total = Stream Bank / Pool x2 + Structure + Criticality</small>

Pipe invert is rusted out in this CMP.

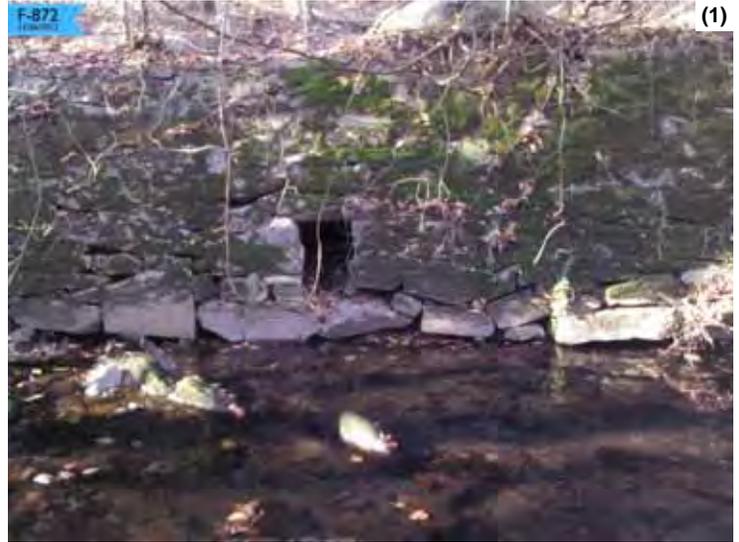
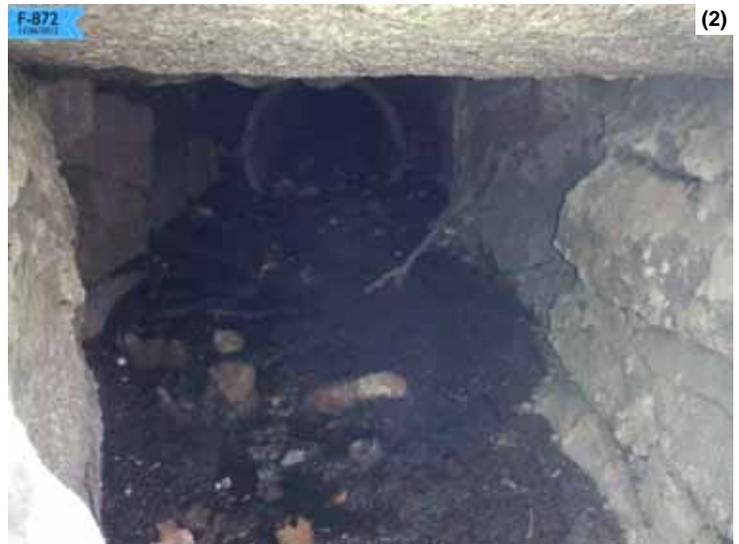
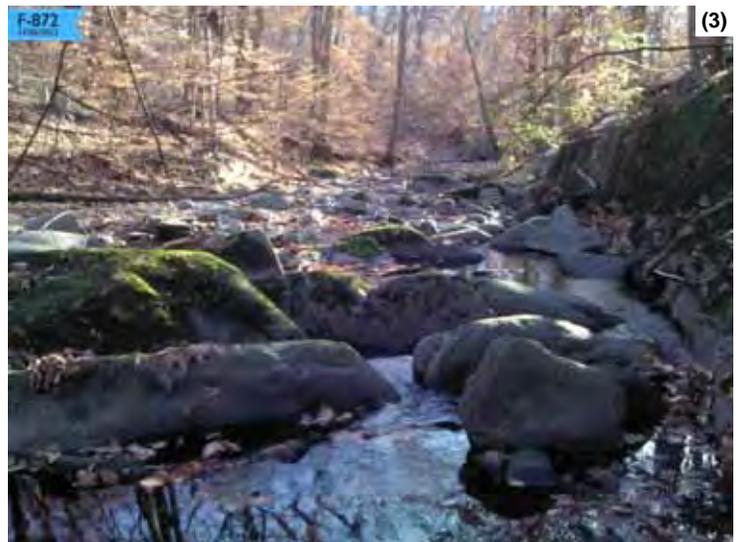
Stream Bank / Pool	<input type="text" value="0"/>	<input type="text" value="Stable"/>	Repairs Recommended? NO
Stream Bank / Pool (x2)	<input type="text" value="0"/>		
Structure	<input type="text" value="1"/>	<input type="text" value="Moderate"/>	
Criticality	<input type="text" value="0"/>	<input type="text" value="Normal"/>	
Total Score	<input type="text" value="1"/>	<small>Total = Stream Bank / Pool x2 + Structure + Criticality</small>

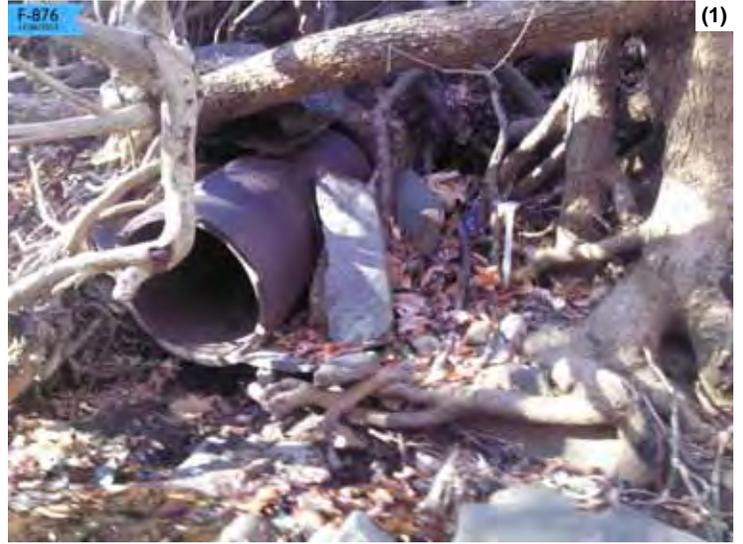
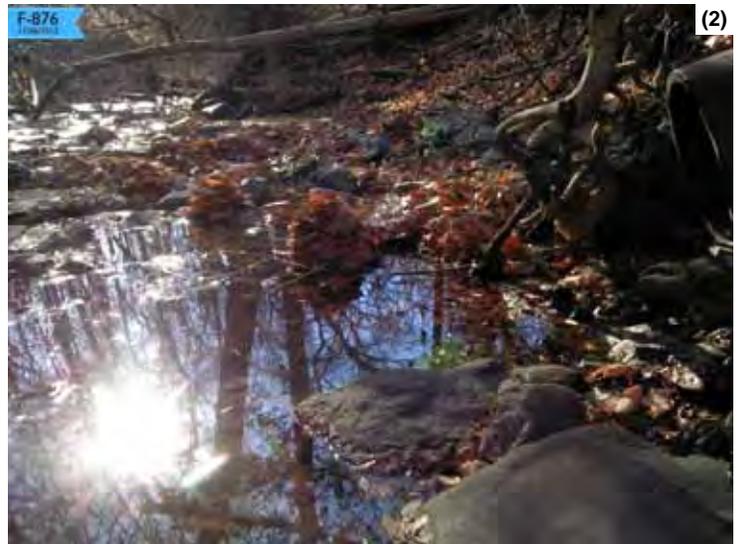
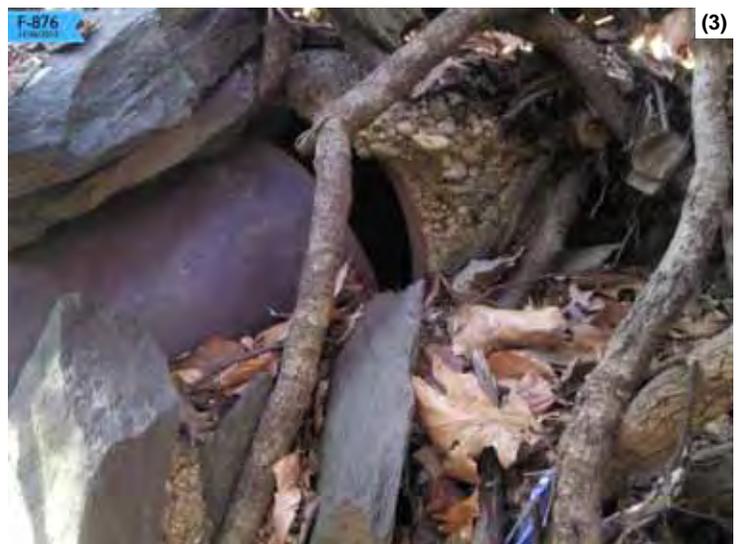
Stream Bank / Pool	<input type="text" value="1"/>	<input type="text" value="Some Erosion"/>	Repairs Recommended? <input checked="" type="checkbox"/> YES
Stream Bank / Pool (x2)	<input type="text" value="2"/>		
Structure	<input type="text" value="2"/>	<input type="text" value="Poor"/>	
Criticality	<input type="text" value="0"/>	<input type="text" value="Normal"/>	
Total Score	<input type="text" value="4"/>	<i>Total = Stream Bank / Pool x2 + Structure + Criticality</i>

Point Repair

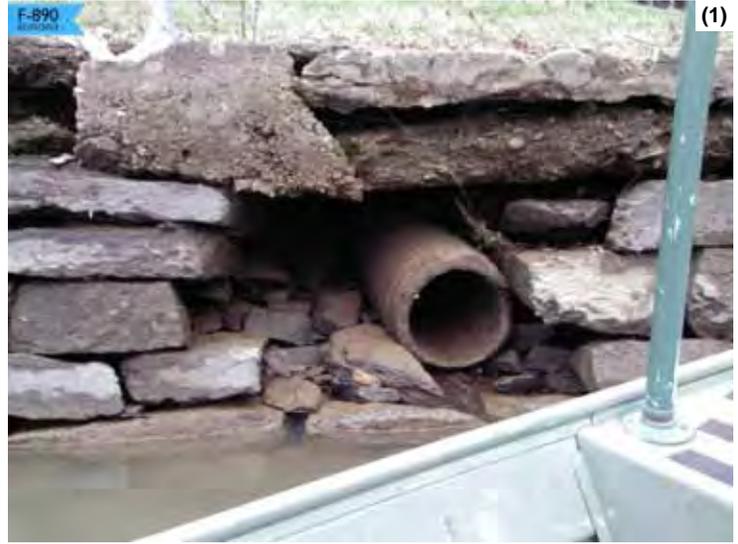
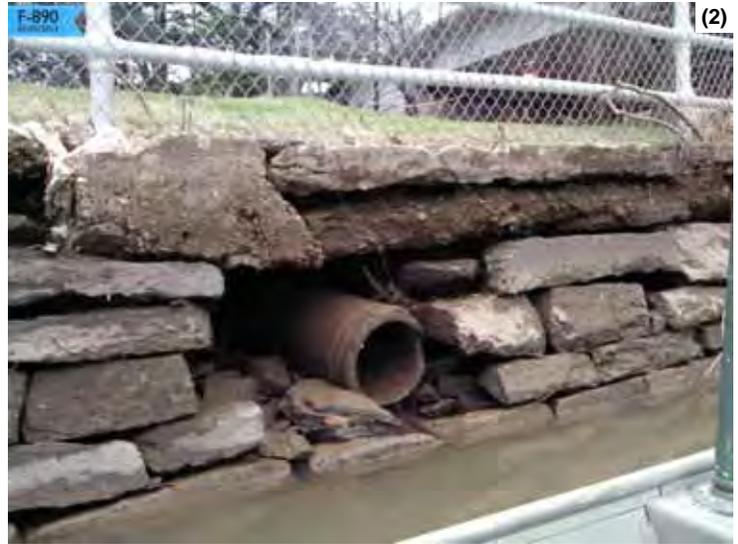
Stone missing from headwall.

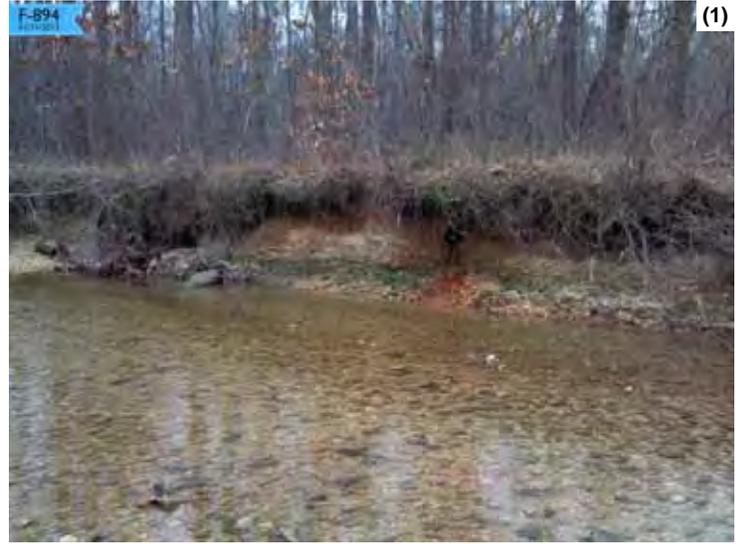
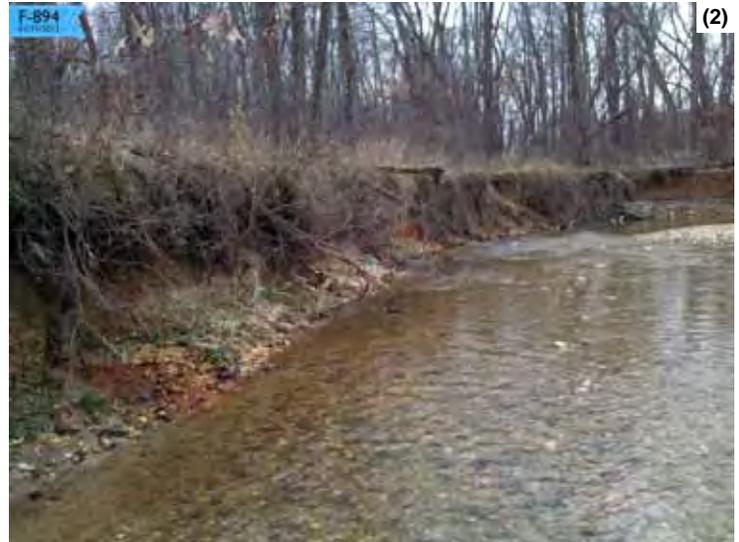
Broken pipe downstream. May be abandoned broken SS. Severe erosion upstream and downstream.

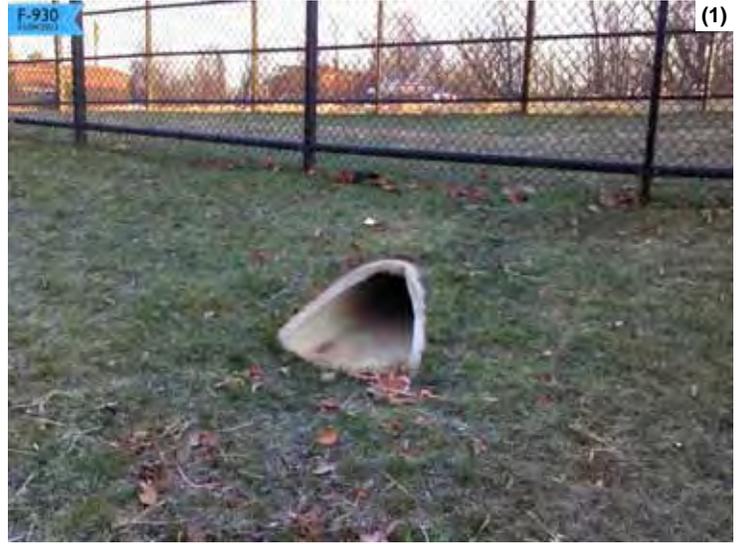
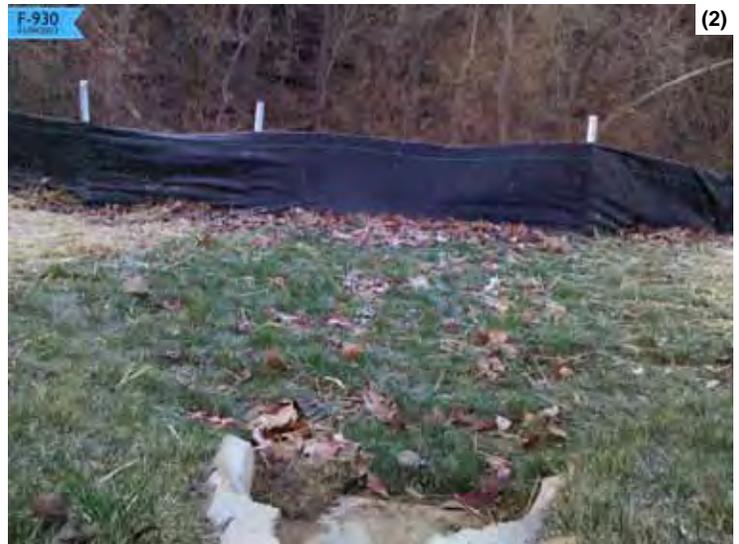
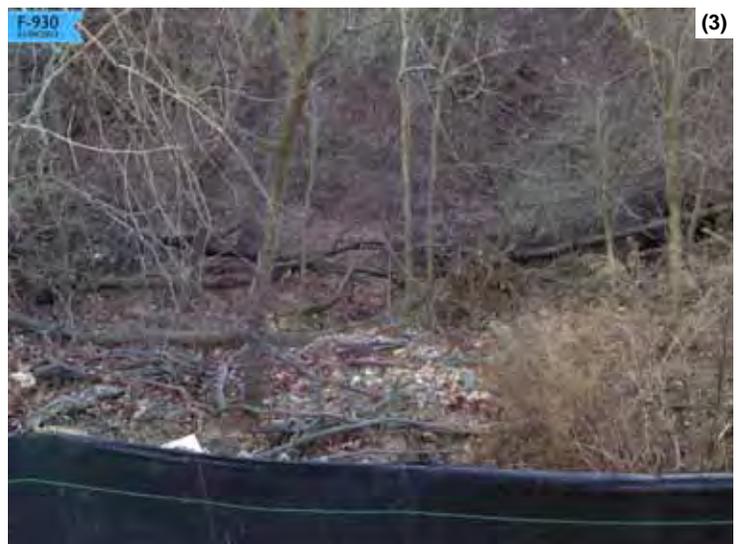
Stream Bank / Pool	<input type="text" value="2"/>	<input type="text" value="Active Erosion"/>	Repairs Recommended? NO
Stream Bank / Pool (x2)	<input type="text" value="4"/>		
Structure	<input type="text" value="0"/>	<input type="text" value="Excellent / Like New"/>	
Criticality	<input type="text" value="0"/>	<input type="text" value="Normal"/>	
Total Score	<input type="text" value="4"/>	<small>Total = Stream Bank / Pool x2 + Structure + Criticality</small>

Significant erosion formed a ravine down the hillside on other side of erosion control barrier. May want to perform inspection of downstream channel to see if repair is needed.

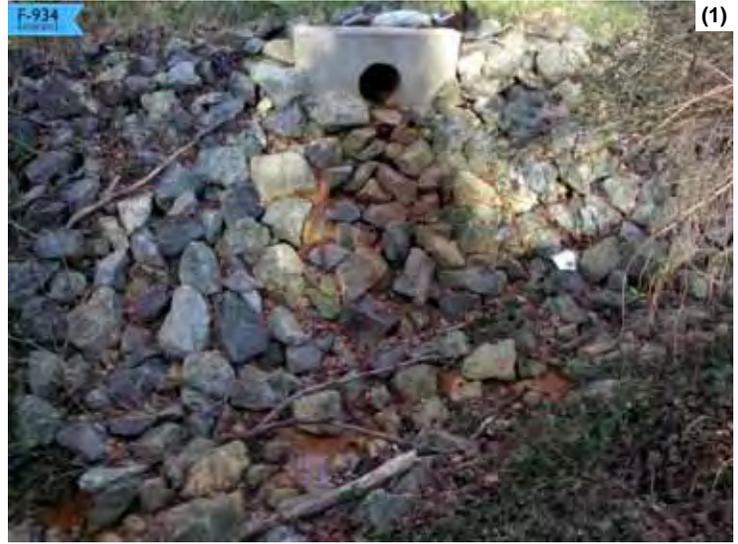
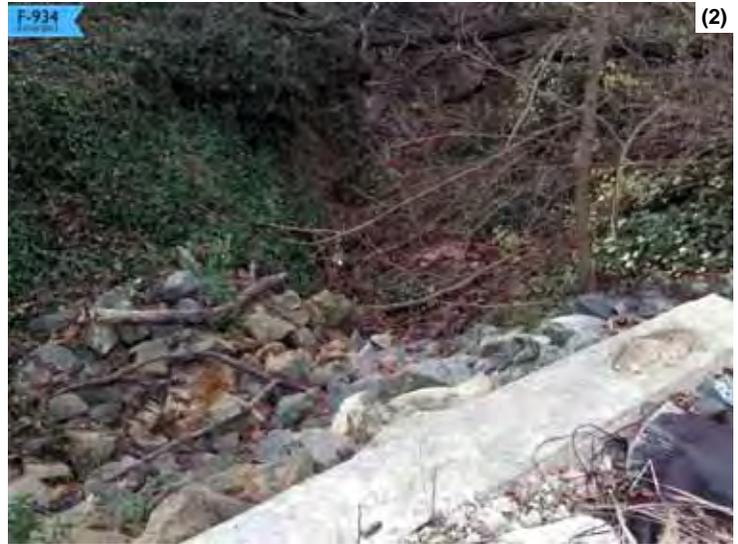
Stream Bank / Pool	<input type="text" value="3"/>	<input type="text" value="Severe Erosion"/>	Repairs Recommended? YES
Stream Bank / Pool (x2)	<input type="text" value="6"/>		
Structure	<input type="text" value="0"/>	<input type="text" value="Excellent / Like New"/>	
Criticality	<input type="text" value="0"/>	<input type="text" value="Normal"/>	
Total Score	<input type="text" value="6"/>	<small>Total = Stream Bank / Pool x2 + Structure + Criticality</small>

Outfall has been repaired in the recent past. Severe erosion remains a problem downstream.
