OUTFALL SUMMARY REPORT

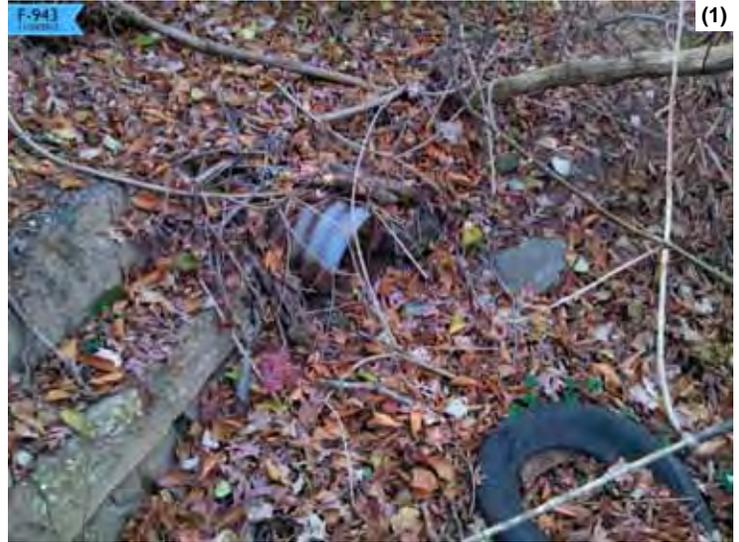
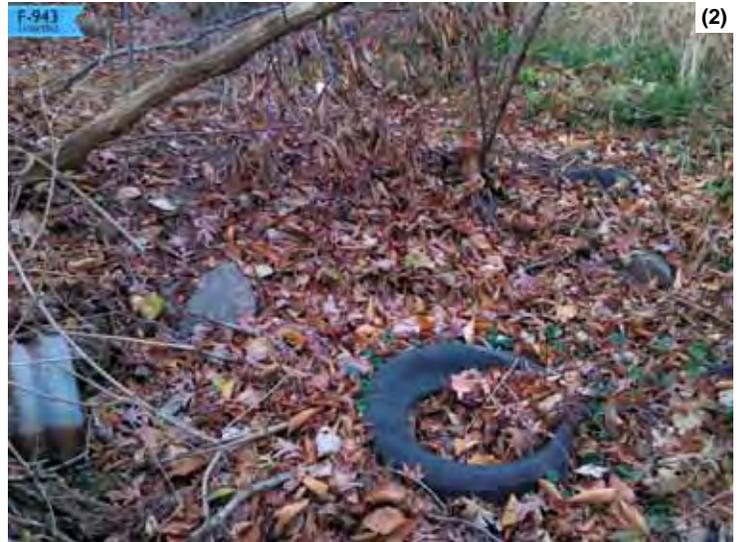
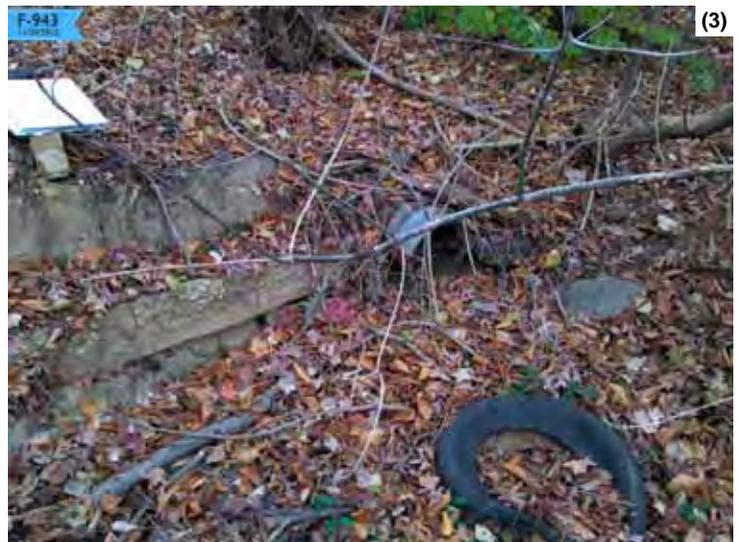
Stream Bank / Pool	<input type="text" value="0"/>	<input type="text" value="Stable"/>	Repairs Recommended? YES
Stream Bank / Pool (x2)	<input type="text" value="0"/>		
Structure	<input type="text" value="1"/>	<input type="text" value="Moderate"/>	
Criticality	<input type="text" value="2"/>	<input type="text" value="Critical"/>	
Total Score	<input type="text" value="3"/>	<small>Total = Stream Bank / Pool x2 + Structure + Criticality</small>

CMP is corroded at invert. Storm manhole directly upstream is open and may be a public safety concern.

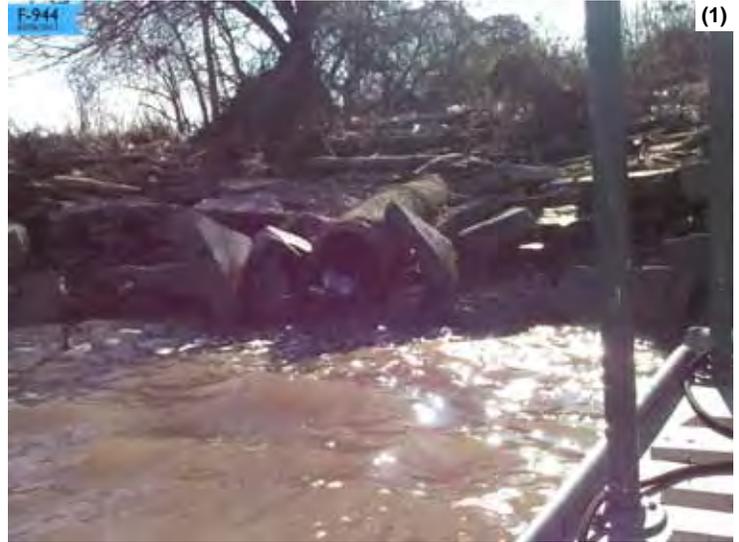
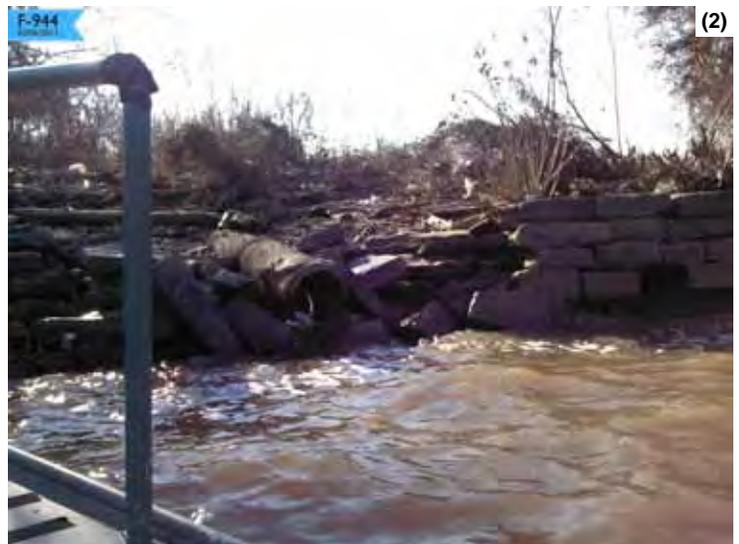
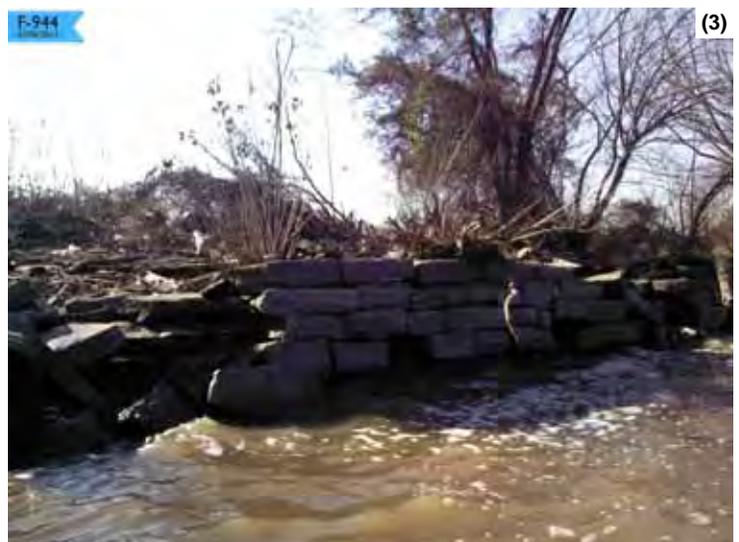
Stream Bank / Pool	<input type="text" value="0"/>	<input type="text" value="Stable"/>	Repairs Recommended? NO
Stream Bank / Pool (x2)	<input type="text" value="0"/>		
Structure	<input type="text" value="2"/>	<input type="text" value="Poor"/>	
Criticality	<input type="text" value="0"/>	<input type="text" value="Normal"/>	
Total Score	<input type="text" value="2"/>	<i>Total = Stream Bank / Pool x2 + Structure + Criticality</i>

Headwall broken; pipe joint separated.

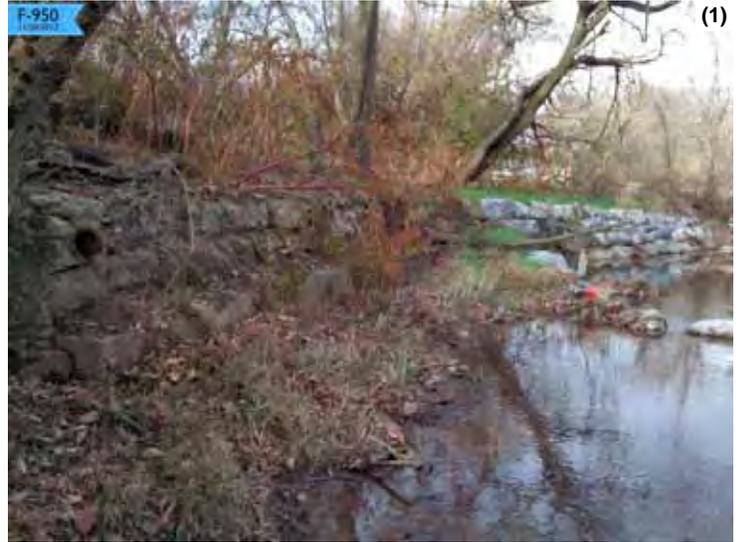
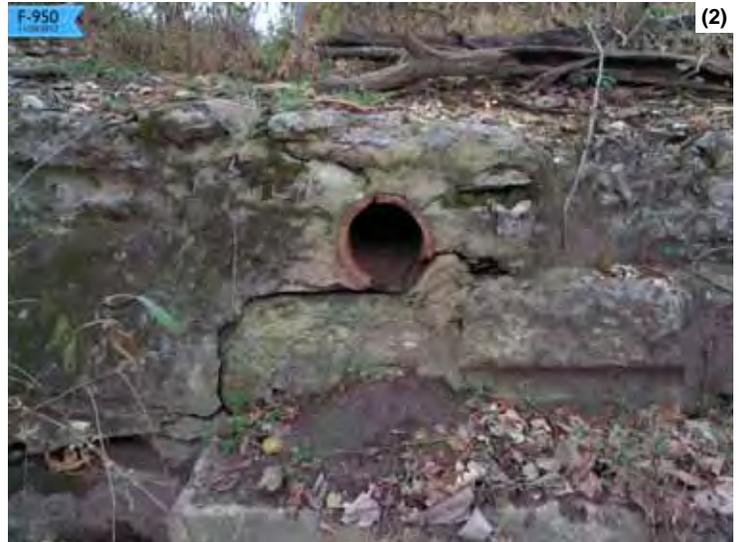
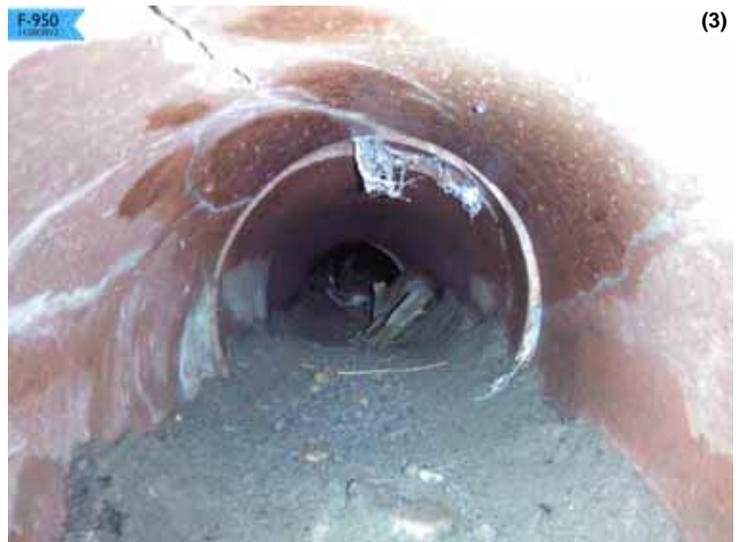
Stream Bank / Pool	<input type="text" value="0"/>	<input type="text" value="Stable"/>	Repairs Recommended? NO
Stream Bank / Pool (x2)	<input type="text" value="0"/>		
Structure	<input type="text" value="1"/>	<input type="text" value="Moderate"/>	
Criticality	<input type="text" value="0"/>	<input type="text" value="Normal"/>	
Total Score	<input type="text" value="1"/>	<small>Total = Stream Bank / Pool x2 + Structure + Criticality</small>

Broken pipe and cracked headwall.

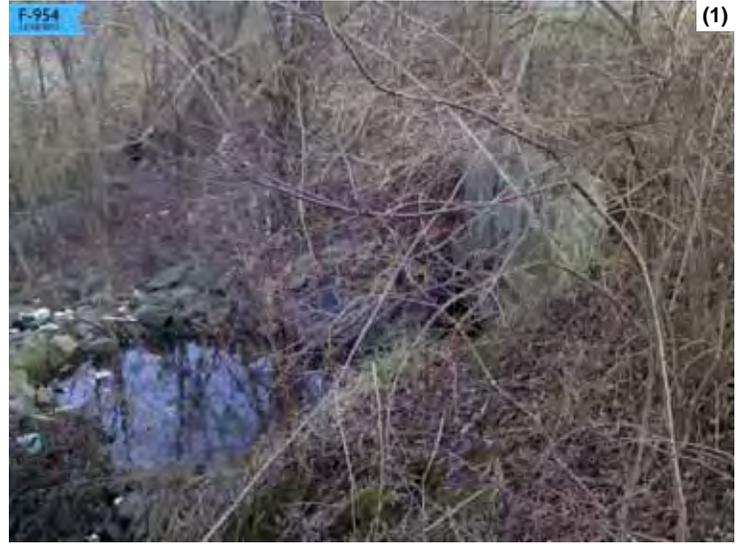
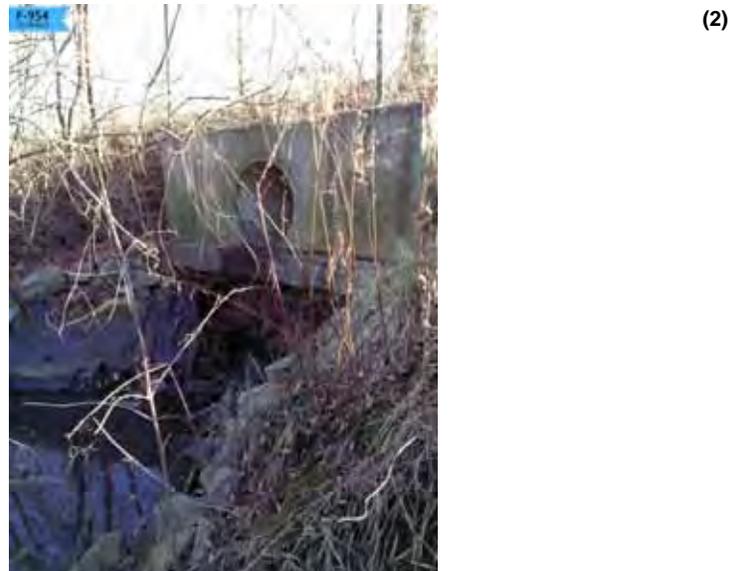
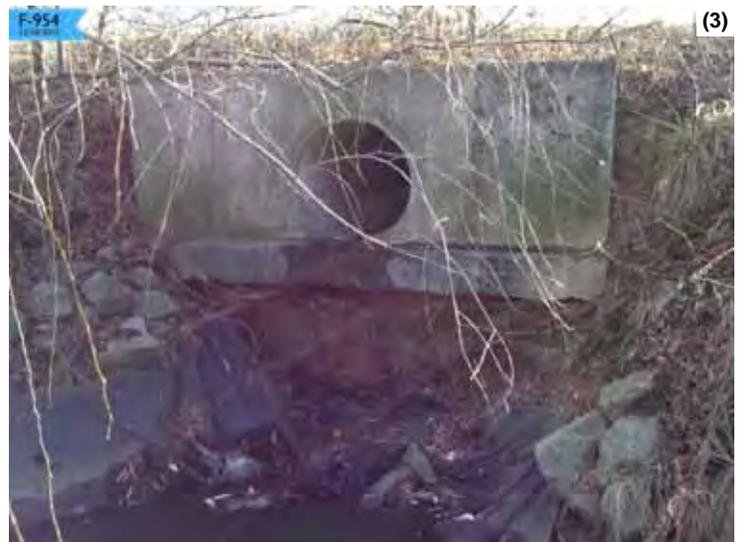
Stream Bank / Pool	<input type="text" value="2"/>	<input type="text" value="Active Erosion"/>	Repairs Recommended? YES
Stream Bank / Pool (x2)	<input type="text" value="4"/>		
Structure	<input type="text" value="1"/>	<input type="text" value="Moderate"/>	
Criticality	<input type="text" value="0"/>	<input type="text" value="Normal"/>	
Total Score	<input type="text" value="5"/>	<small>Total = Stream Bank / Pool x2 + Structure + Criticality</small>

30" deep erosion under outfall headwall. - Notify DDOT of repairs needed?

Point Repair

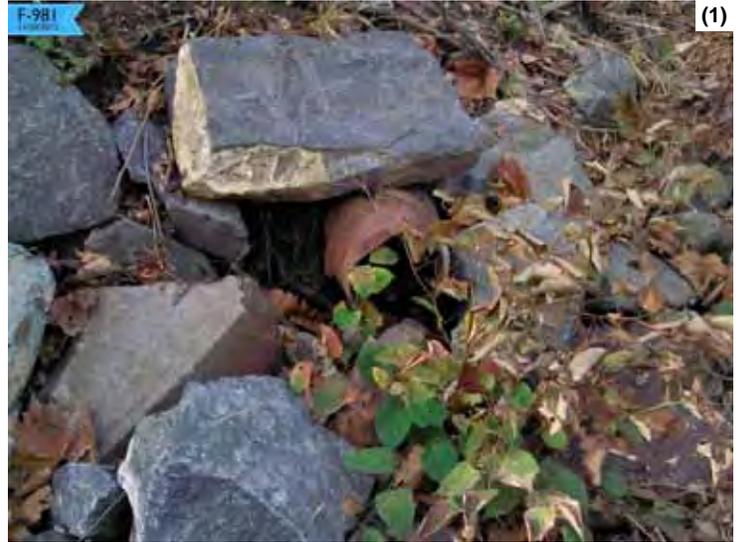
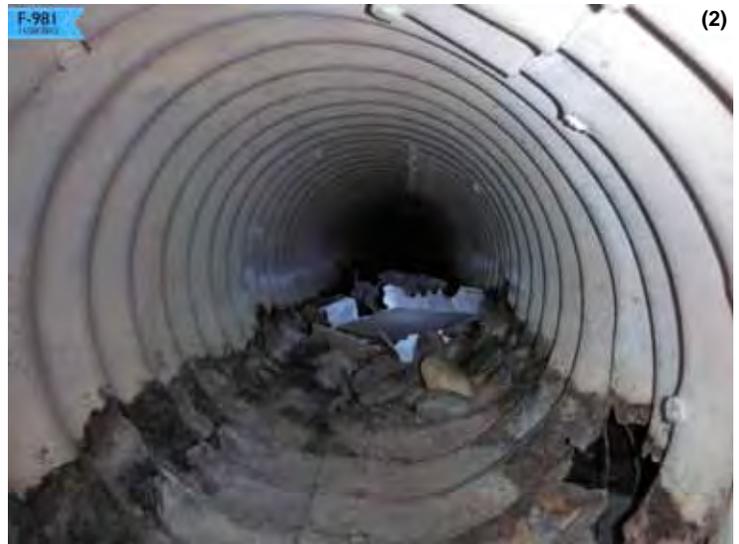
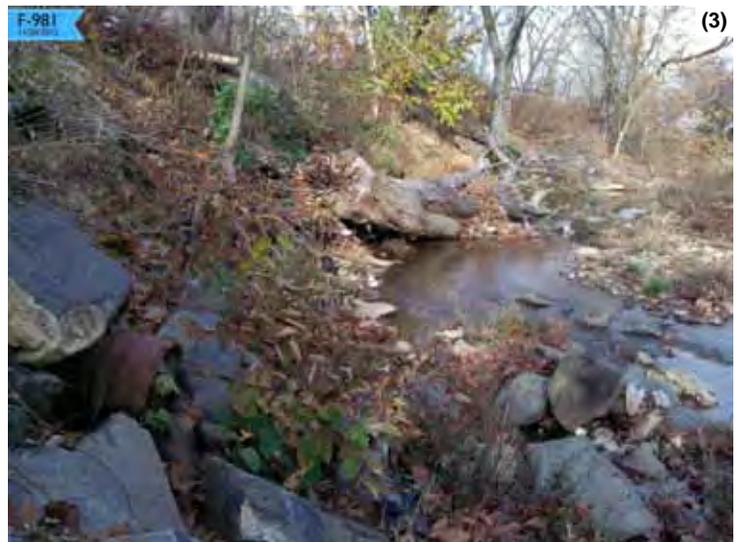
Stream Bank / Pool	<input type="text" value="0"/>	<input type="text" value="Stable"/>	Repairs Recommended? NO
Stream Bank / Pool (x2)	<input type="text" value="0"/>		
Structure	<input type="text" value="2"/>	<input type="text" value="Poor"/>	
Criticality	<input type="text" value="0"/>	<input type="text" value="Normal"/>	
Total Score	<input type="text" value="2"/>	<small>Total = Stream Bank / Pool x2 + Structure + Criticality</small>

Deteriorated CMP in non-critical area.

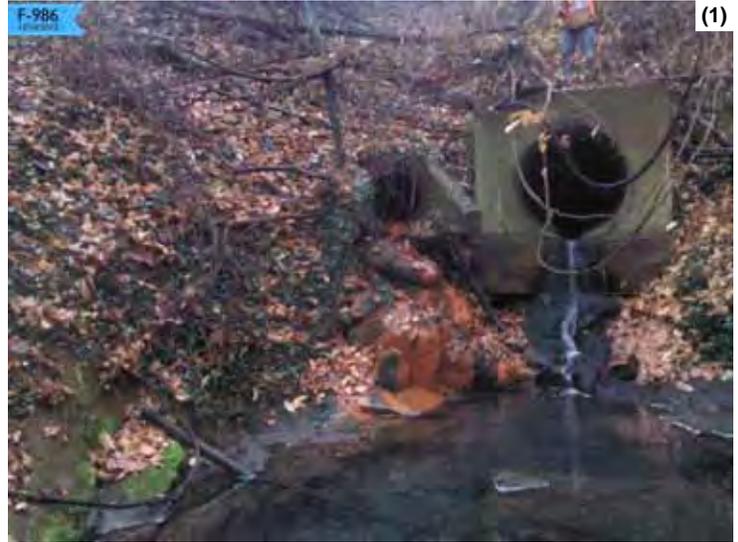
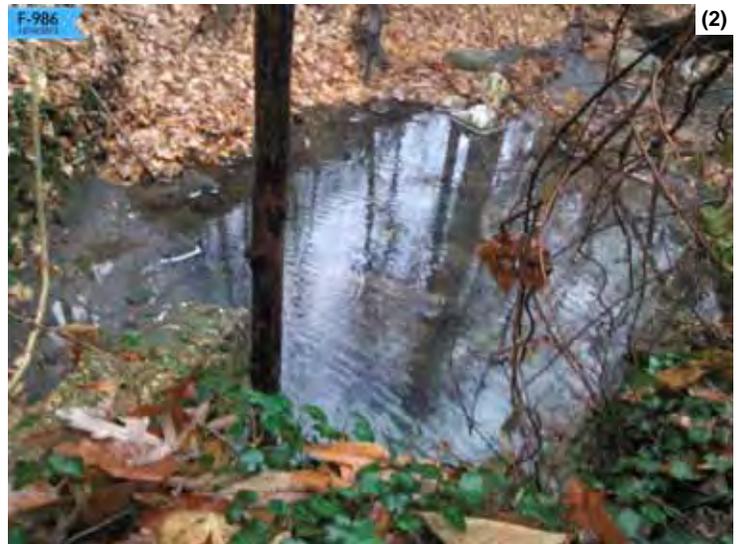
Stream Bank / Pool	<input type="text" value="1"/>	<input type="text" value="Some Erosion"/>	Repairs Recommended? NO
Stream Bank / Pool (x2)	<input type="text" value="2"/>		
Structure	<input type="text" value="0"/>	<input type="text" value="Excellent / Like New"/>	
Criticality	<input type="text" value="0"/>	<input type="text" value="Normal"/>	
Total Score	<input type="text" value="2"/>	<i>Total = Stream Bank / Pool x2 + Structure + Criticality</i>

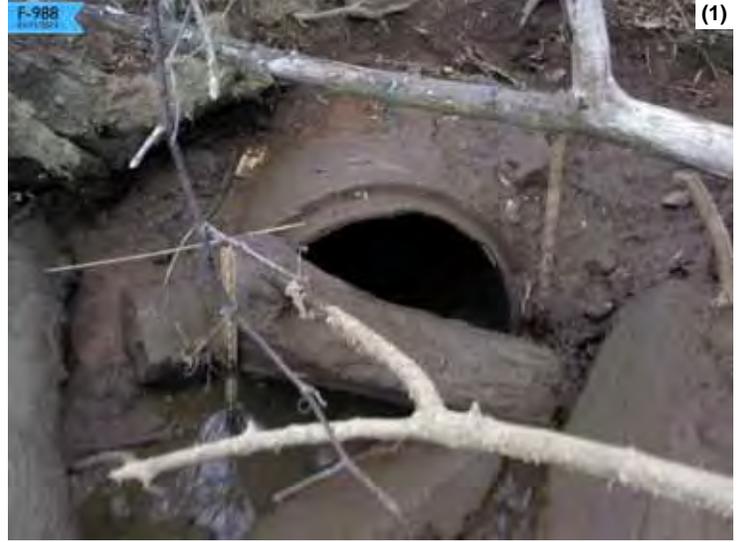
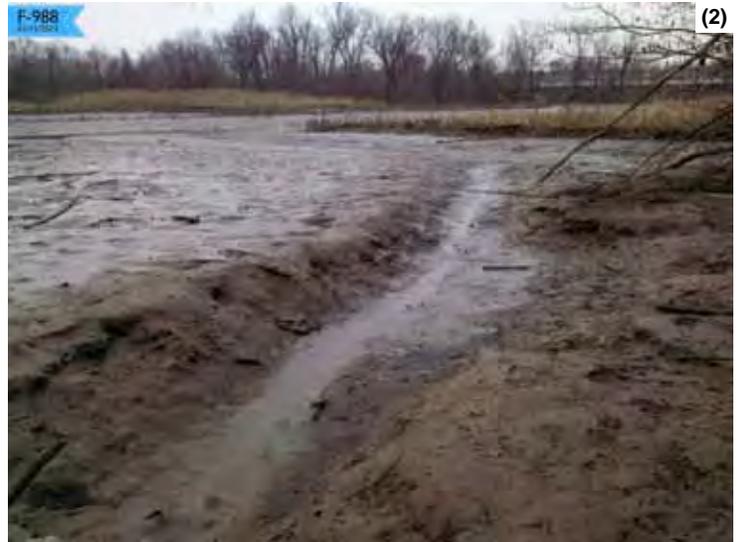
Stream Bank / Pool	<input type="text" value="0"/>	<input type="text" value="Stable"/>	Repairs Recommended? NO
Stream Bank / Pool (x2)	<input type="text" value="0"/>		
Structure	<input type="text" value="1"/>	<input type="text" value="Moderate"/>	
Criticality	<input type="text" value="0"/>	<input type="text" value="Normal"/>	
Total Score	<input type="text" value="1"/>	<small>Total = Stream Bank / Pool x2 + Structure + Criticality</small>

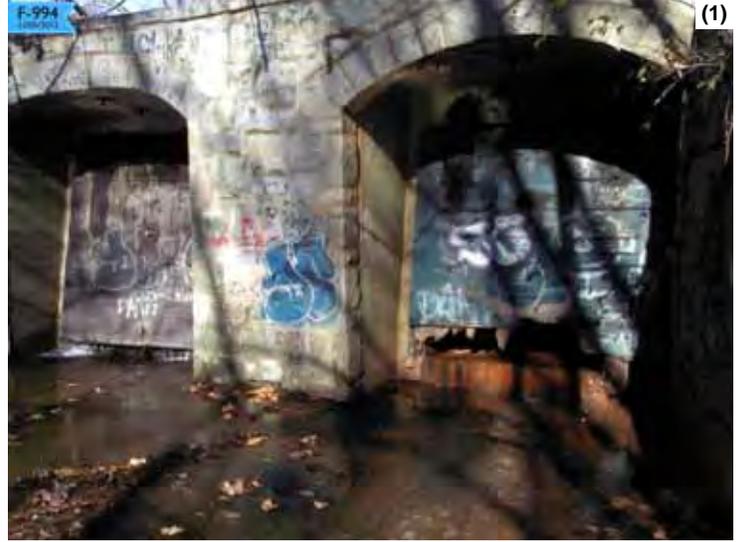
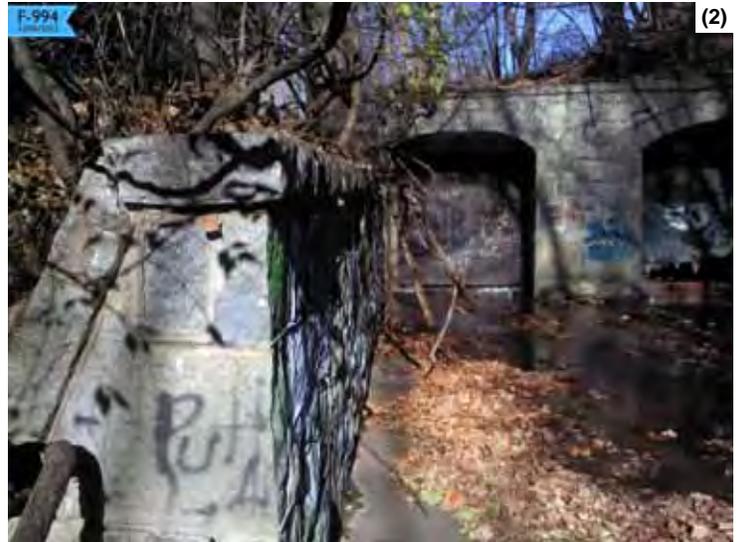
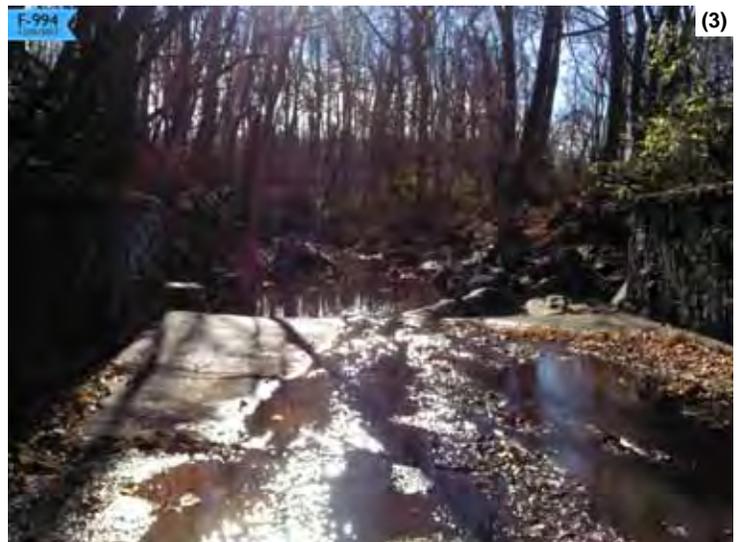
Stream Bank / Pool	<input type="text" value="0"/>	<input type="text" value="Stable"/>	Repairs Recommended? NO
Stream Bank / Pool (x2)	<input type="text" value="0"/>		
Structure	<input type="text" value="1"/>	<input type="text" value="Moderate"/>	
Criticality	<input type="text" value="0"/>	<input type="text" value="Normal"/>	
Total Score	<input type="text" value="1"/>	<i>Total = Stream Bank / Pool x2 + Structure + Criticality</i>

Double outfall (see F-366); broken wingwall (left) and cracked spillway.

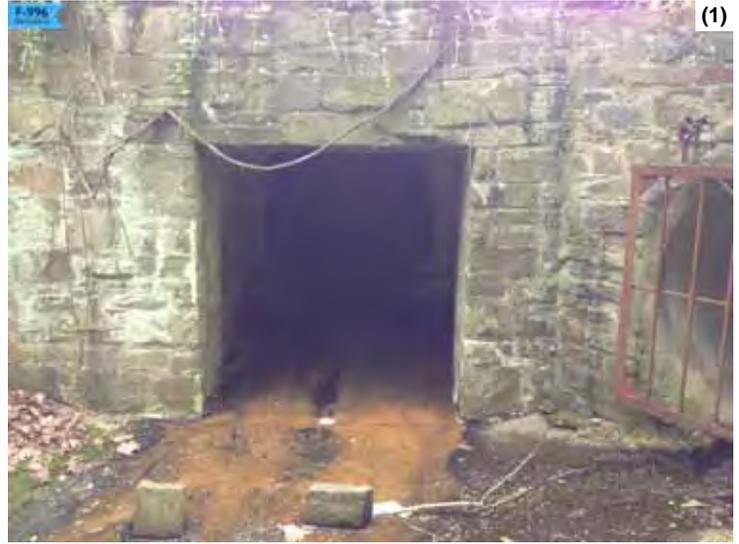
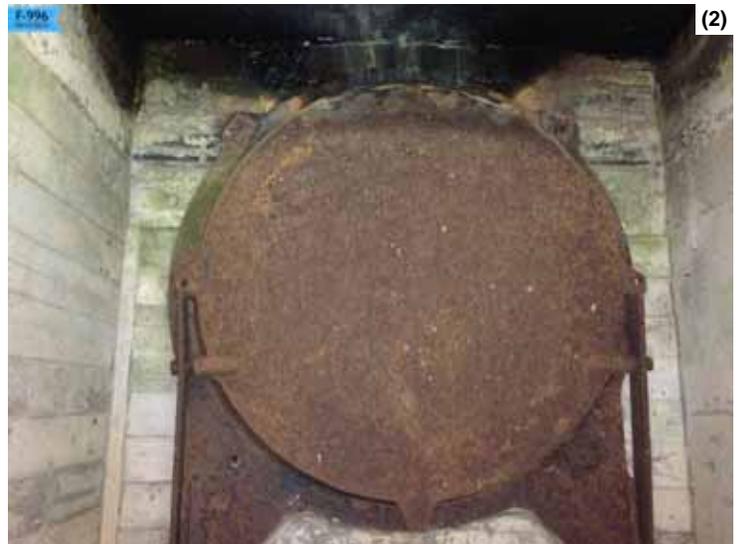
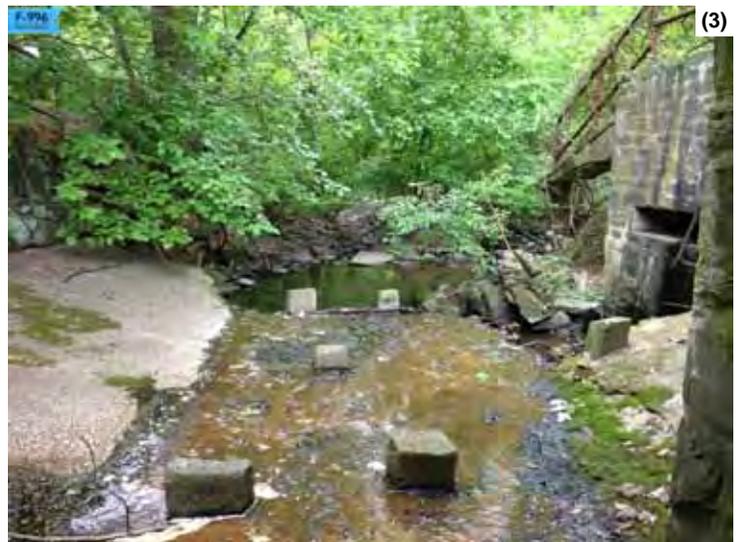
Stream Bank / Pool	<input type="text" value="0"/>	<input type="text" value="Stable"/>	Repairs Recommended? NO
Stream Bank / Pool (x2)	<input type="text" value="0"/>		
Structure	<input type="text" value="1"/>	<input type="text" value="Moderate"/>	
Criticality	<input type="text" value="2"/>	<input type="text" value="Critical"/>	
Total Score	<input type="text" value="3"/>	<i>Total = Stream Bank / Pool x2 + Structure + Criticality</i>
